TECHNICAL BULLETIN

Steering Rack – Surface Cracks – Service Action S450

57-20
Amended
8/95

MODEL XJS (4.0L) Range 1995 MY

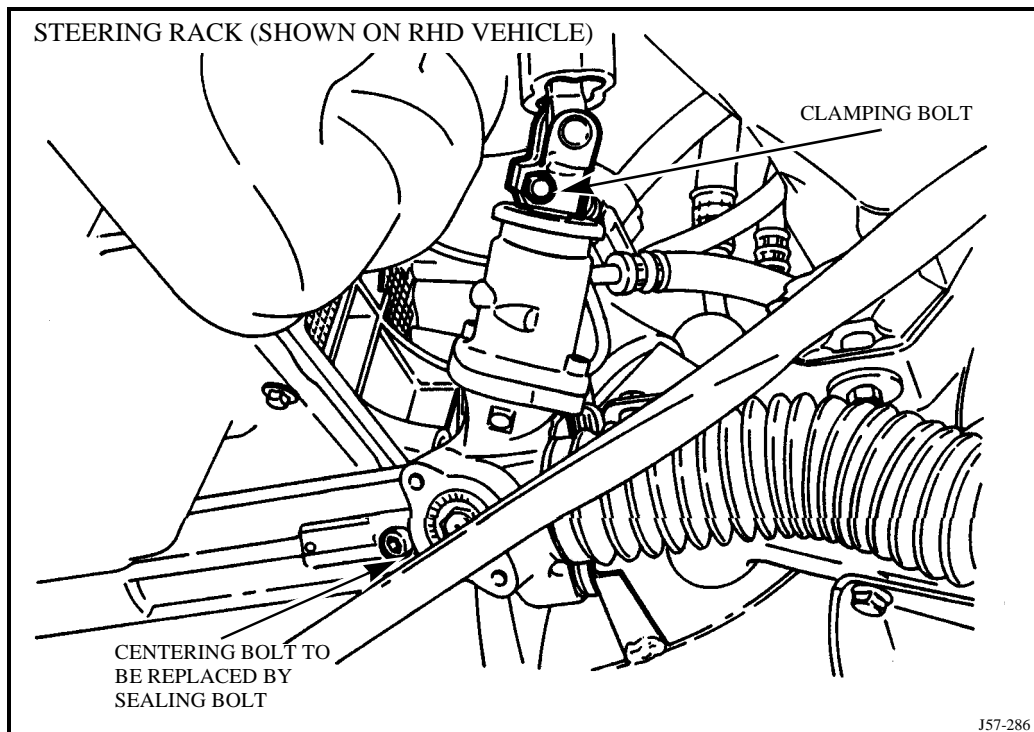
ILLUSTRATION 1

4. Remove the clamping bolt and nut that attach the steering shaft to the pinion, Illustration 1.
5. Turn the ignition key to position 1 and turn the steering wheel to the straight-ahead position. Turn the key to the OFF position and remove.

- Insert the clamping bolt and nut (Illustration 1) and tighten to 17.702 - 22.127 lb ft (24 - 30 Nm).
- Connect the supply and return hoses.
- Connect the tie rod ends to the steering arms and tighten to 44.991 - 50.892 lb ft (61 - 69 Nm).
- Remove the centering bolt and replace it with the sealing bolt (JZS 100046) and washer (JZW 100019), Illustration 1. Tighten the bolt to 4 - 5.25 lb ft (5.5 - 8.5 Nm).
- Refill the steering system, reconnect the battery, run the engine and turn the steering wheel from lock to lock to purge the air from the system. Check the fluid level.
- Check/adjust the front wheel alignment.**
- Reset the clock.
