# TECHNICAL BULLETIN

## Steering Pull – Correction Procedure

**60-7**

MODEL Sedan Range 1988 - 94 MY

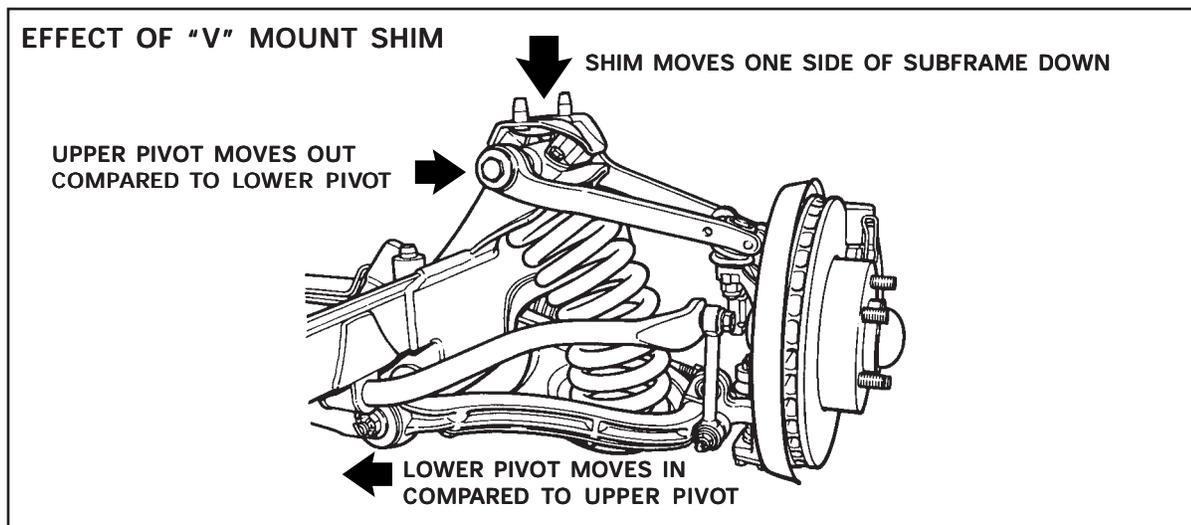
ILLUSTRATION 1

Steering pull on Sedan Range vehicles may be caused by a camber imbalance between the right and left side front suspension. A method of shimming a V-mount on one side has been developed to reduce this camber imbalance. In extreme cases, caster may have to be biased to reduce the steering pull.

1. Inspect all front suspension components for wear or damage. Verify that the tires are the correct size, brand and type, and are properly inflated. If all four tires are not identical, advise the customer that it may not be possible to eliminate the steering pull.
2. Install the suspension mid-laden tools. Adjust the front mid-laden tools (JD133) to the correct setting height. Check the wheel alignment. For current specifications, refer to Bulletin 60-5.
3. Attempt to correct the camber imbalance using up to three 1mm shims. If this does not eliminate the steering pull, bias the caster.

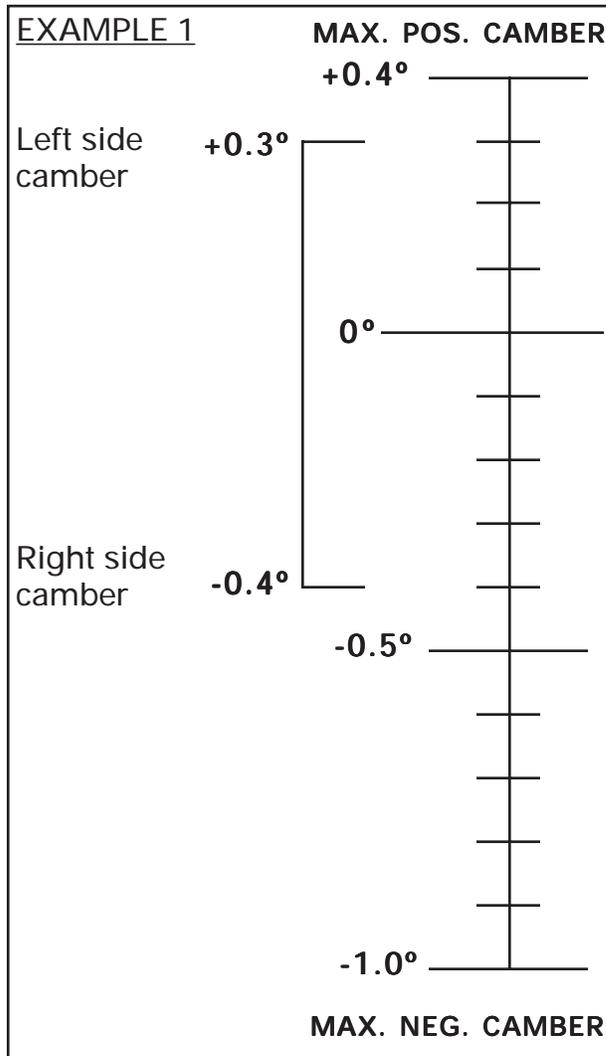
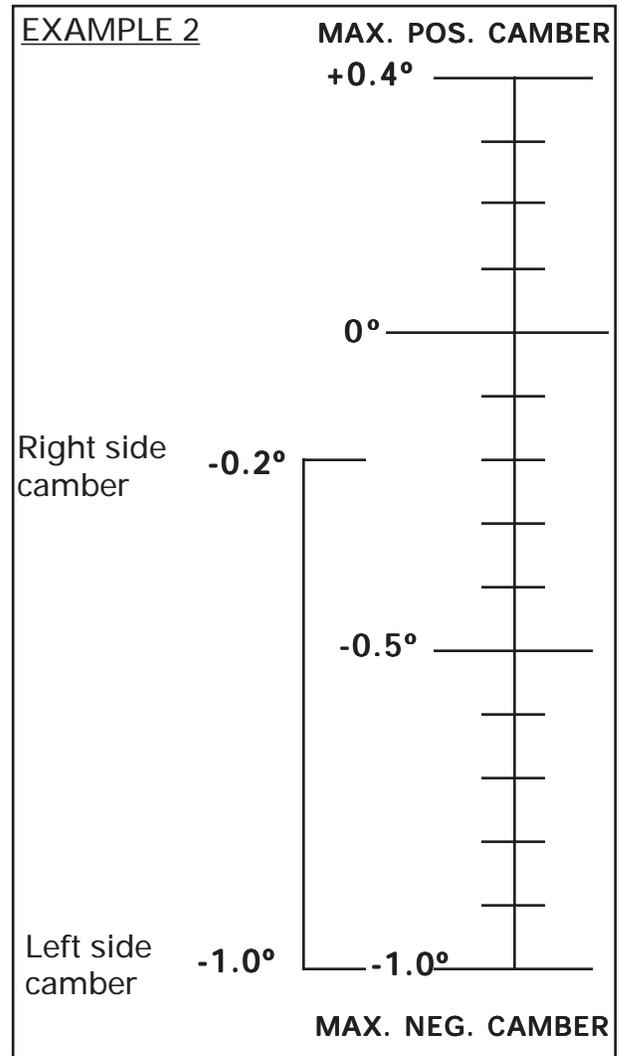
EXAMPLE 1

Left side camber = +0.3°

Right side camber = -0.4°

$$\begin{aligned} \text{Camber imbalance} &= 0.3 - (-0.4)^\circ \\ &= \underline{0.7}^\circ \end{aligned}$$

EXAMPLE 2

Left side camber = -1.0°

Right side camber = -0.2°

$$\begin{aligned} \text{Camber imbalance} &= -1.0 - (-0.2)^\circ \\ &= \underline{-0.8}^\circ \end{aligned}$$

Insert 3 shims on right side "V" mount to reduce imbalance to 0.4°.

Insert 3 shims on left side "V" mount to reduce imbalance to -0.5°.
