TECHNICAL BULLETIN

Front Brake Rattle – Disc Shield – Install New Retaining Screws

70-25

MODEL Sedan Range 1994 - 95 MY
VIN 674930 - 756474

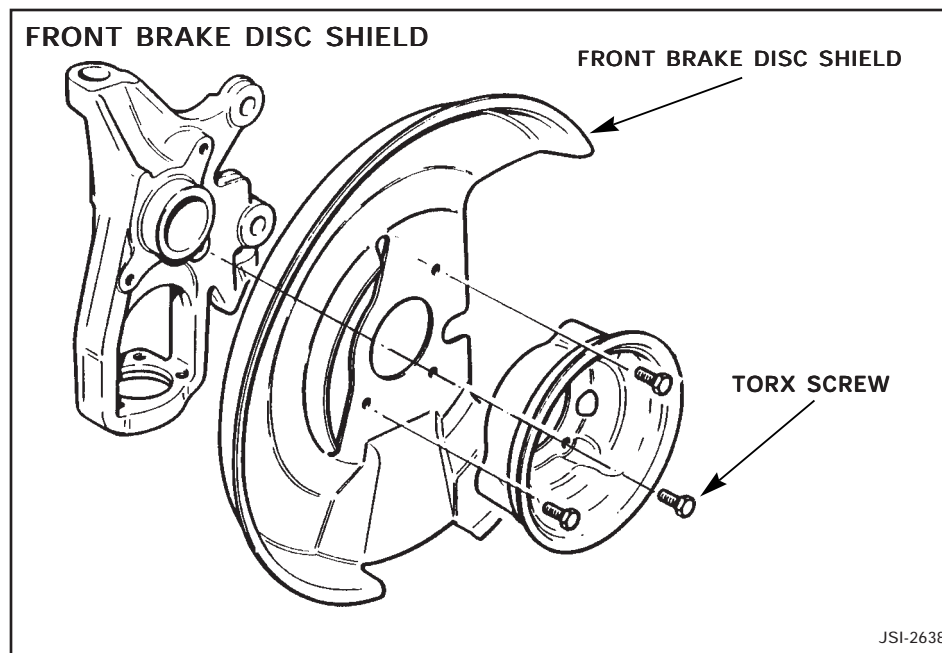
ILLUSTRATION 1

The noise is caused by loosening of the Torx screws that secure the brake disc shield and the water shield to the stub axle, allowing the shields to vibrate.

In case of a customer complaint remove the hub assembly as described in Section 70.10.18 of the XJ6 - XJ12 Saloon Range Service Manual. Remove and discard the old screws. Install the new screws listed in the Parts Information and torque to 7.4 - 8.8 lb. ft. (10 -12 Nm.)

NOTE: When the hub is removed, the seal must be replaced with a new one using Special Tool JD 179. The seal face that contacts the hub must be coated with a special lubricant (Shell Retinex LC). Thoroughly clean all traces of the previous lubricant from the hub.
