# TECHNICAL BULLETIN

## Front Brake Rattle – Disc Shield – Install New Retaining Screws

70-25

MODEL Sedan Range 1994 - 95 MY  
VIN 674930 - 756474

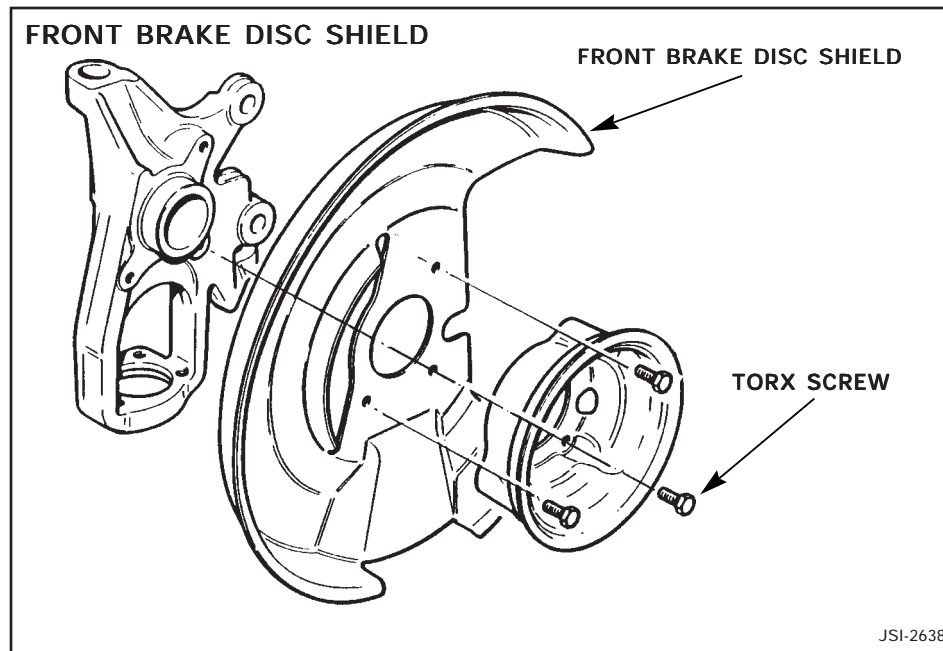
ILLUSTRATION 1

The noise is caused by loosening of the Torx screws that secure the brake disc shield and the water shield to the stub axle, allowing the shields to vibrate.

In case of a customer complaint remove the hub assembly as described in Section 70.10.18 of the XJ6 - XJ12 Saloon Range Service Manual. Remove and discard the old screws. Install the new screws listed in the Parts Information and torque to 7.4 - 8.8 lb. ft. (10 -12 Nm.)

**NOTE:** When the hub is removed, the seal must be replaced with a new one using Special Tool JD 179. The seal face that contacts the hub must be coated with a special lubricant (Shell Retinex LC). Thoroughly clean all traces of the previous lubricant from the hub.
