# TECHNICAL BULLETIN

## Hood Liner – Modification – Service Action S437

**76-105**

MODEL XJ12 1994 MY

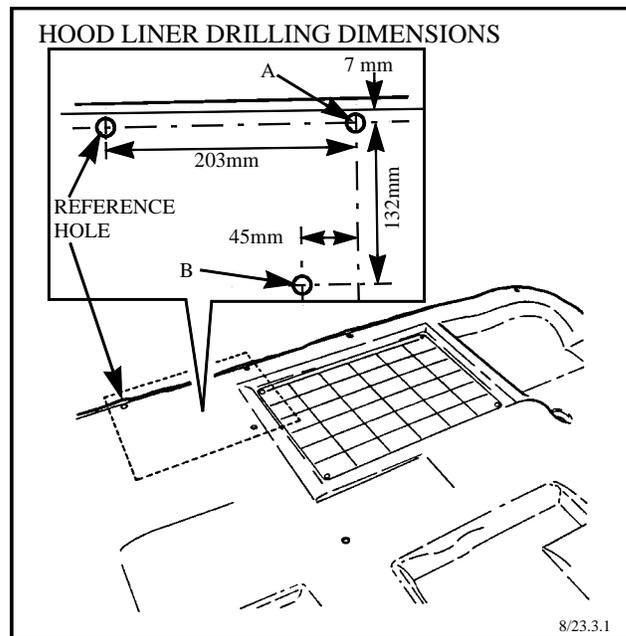
ILLUSTRATION 1

Hood liners may sag causing an unsightly engine bay appearance and abrasion to the liner.

4. Mark the liner for two new 5/16" (8mm) holes, A and B (Illustration 1).

5. With a "wad punch" or similar tool, punch two, clean, 5/16" (8mm) holes as indicated.
