# TECHNICAL BULLETIN

## Revised Underscuttle – Revised Mounting Method – Installation Instructions

76-108

MODEL Sedan Range 1990 - 1992 MY

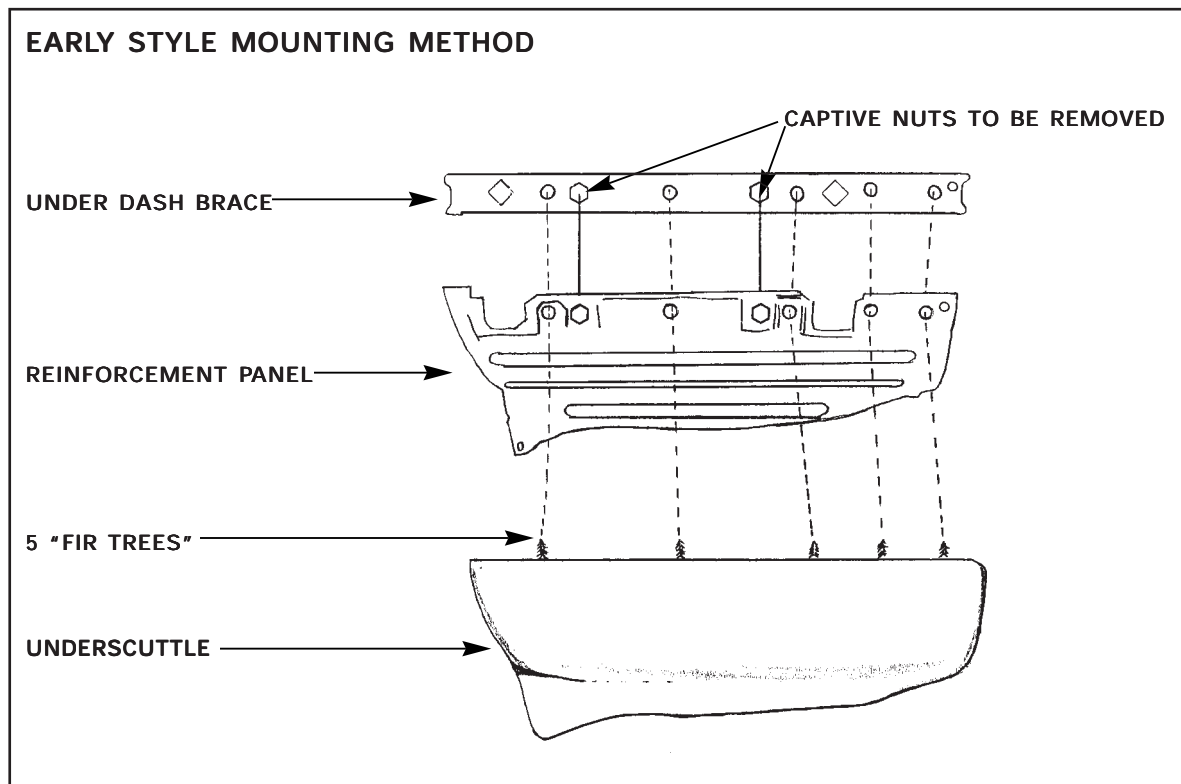
ILLUSTRATION 1

Replacement underscuttle panels have only 3 "fir tree" fasteners and do not fit directly in place of the previous panel with 5 "fir tree" fasteners.

1. After removing screws, use dash liner tool # JD 188 to remove the underscuttle from the vehicle.
2. Remove the reinforcement panel.
3. Remove and discard the two captive nuts indicated in Illustration 1.
