TECHNICAL BULLETIN

Seat Track Assembly – Repair/Replace Guidelines

76-129

MODEL 1993-94 MY Sedan Range

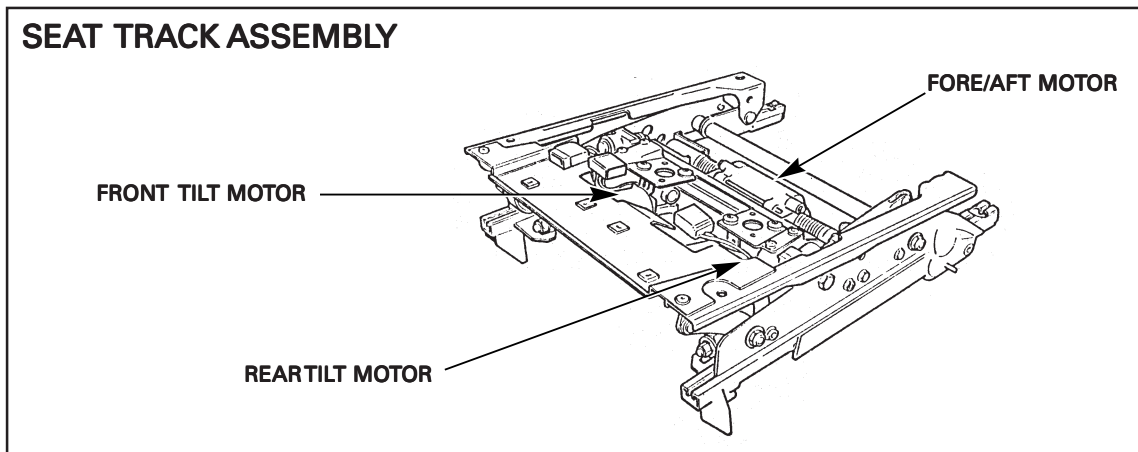
ILLUSTRATION 1

The entire seat track assembly (Illustration 1) on the above vehicles does not need to be replaced when the fore/aft motors or cushion tilt motor, gearbox, or potentiometer is inoperative. These motors/gearboxes/potentiometers are available separately from the seat track assembly. This bulletin describes under what conditions replacing the seat track assembly is not justified.

Do **not** replace the complete seat track assembly under following conditions:

- the cushion tilt motor is damaged.
- the potentiometer for the cushion tilt motor is damaged.
- the transmission of the cushion tilt motor is damaged.
- the fore/aft motor is damaged.
- the potentiometer for the fore/aft motor is damaged.
- the transmission shafts for the fore/aft motor are stripped.

Replace the complete seat track assembly only under following conditions:

- if the track assembly is cracked.
- if the track assembly has a broken weld.
- if the track assembly allows excessive rocking of the seat.

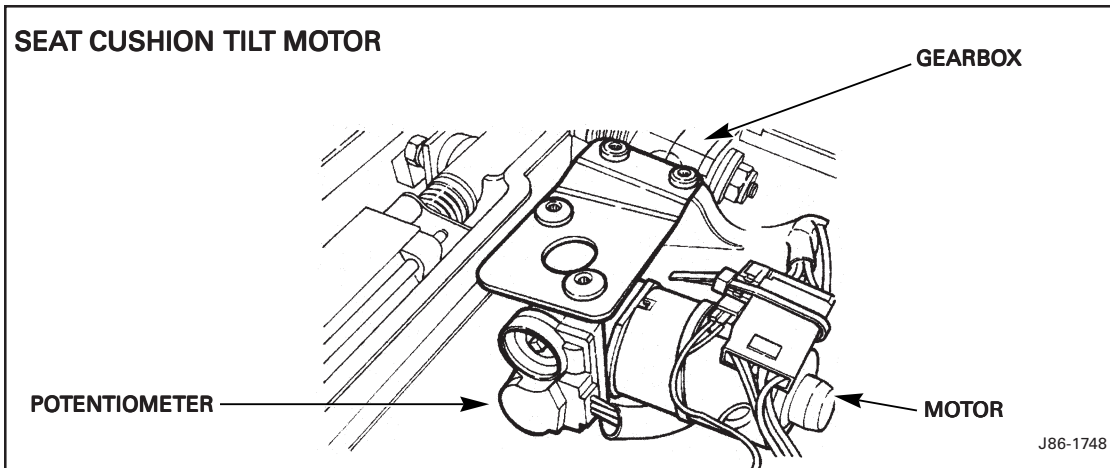
ILLUSTRATION 2

Refer to Volume 4, Section 86, pages 86-77 to 86-88 of the XJ6-XJ12 Saloon Range Service Manual for the procedures to replace the motors and/or potentiometers. Since the cushion tilt motors come as an assembly with the gearboxes and potentiometers, (Illustration 2) the relationship between the linkage and the potentiometer is already set.
