TECHNICAL BULLETIN

Wind Noise Around Windshield – Repair Procedure

76-94

MODEL Sedan Range 1994 MY

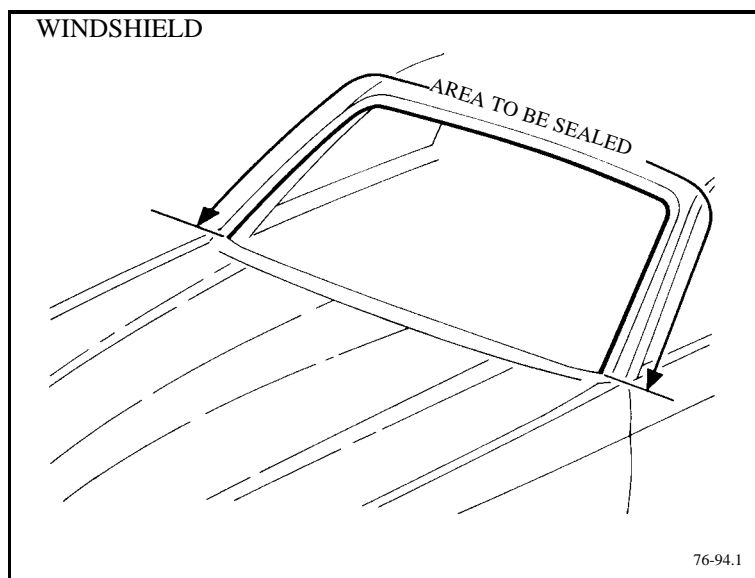
ILLUSTRATION 1

Wind noise around the windshield dependant on vehicle speed, wind strength and wind direction. This noise is caused by the vibration of the outer edge of the windshield finisher retaining rubber.

1. Inspect the underside of the windshield finisher retaining rubber to be sure it is clean and dry.
2. Apply masking tape to protect the retaining rubber in the area to be sealed (Illustration 1).
