TECHNICAL BULLETIN

Cooling Fans – Inoperative or Operate With Ignition Off – Reseal Ground Wires

86-140

MODEL Sedan Range 1992 – 1994 MY DATE 12/94
VIN 667579 - 708757

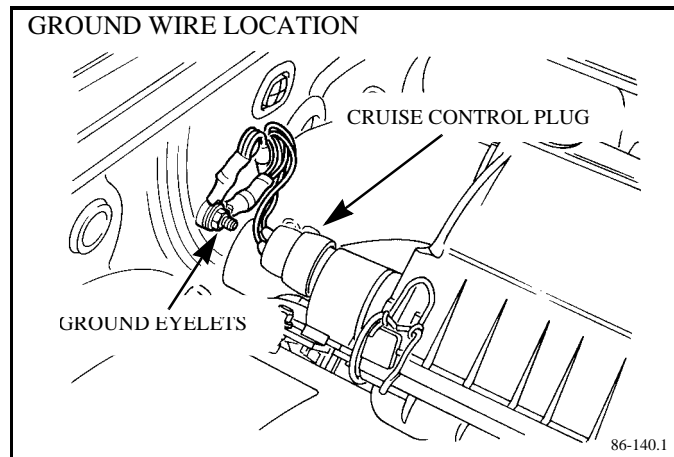
ILLUSTRATION 1

Cooling fans that are inoperative or operate while the ignition is switched off can be the result of corrosion in the cooling fan control module. The corrosion is caused by water entering the ground wire cores and traveling inside the wire insulation to the module.

1. With the battery ground cable disconnected, disconnect the cruise control pump harness plug and the two ground eyelets on the left inner front fender panel (Illustration 1).
