**Rear Suspension Hub Carrier Fulcrum Bolts –
Revised Specification –
Replace – Service Action S468****MODEL**1998 MY XK8 Range
1998 MY V8 XJ Series**VIN**025588-026519
837386-840302**Issue:**

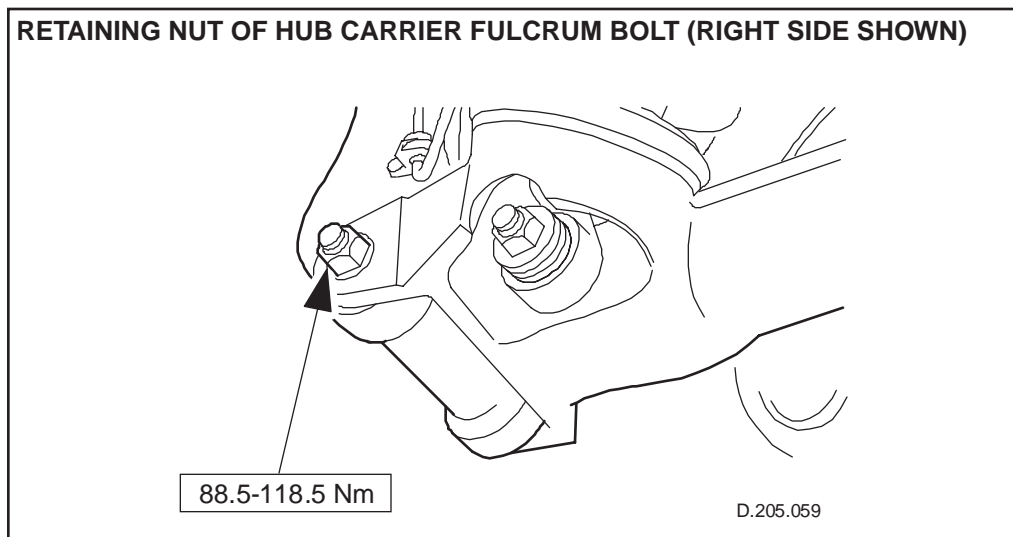
ILLUSTRATION 1

1. Raise the vehicle on a lift so that the rear suspension arms are supported while still allowing access to the nut (Illustration 1) and also to the head of the fulcrum bolt (Illustration 2).

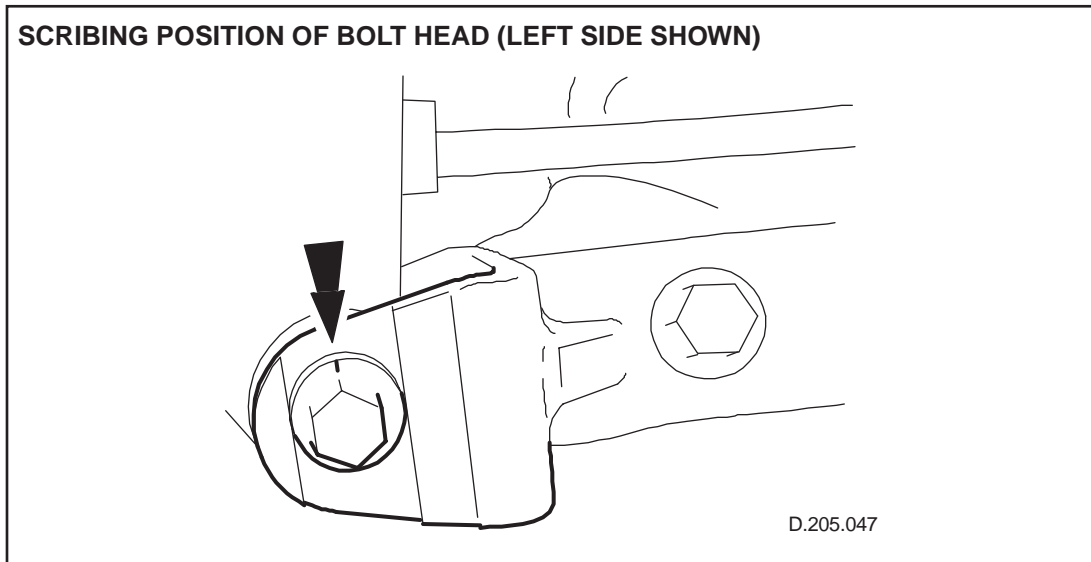
ILLUSTRATION 2

2. Remove the rear road wheels.
3. If necessary, clean the head of each fulcrum bolt so as to be able to identify the marker line stamped on the head of each bolt (Illustration 2). Use a fine-pointed scribe to mark on each wishbone the location of the marker line, prior to dismantling. The marker line will not necessarily be in the location illustrated, depending on previous adjustment to effect correct wheel alignment.
