Rear Suspension Hub Carrier Fulcrum Bolts –  
Revised Specification –  
Replace – Service Action S468

MODEL  
1998 MY XK8 Range  
1998 MY V8 XJ Series  
VIN  
025588-026519  
837386-840302

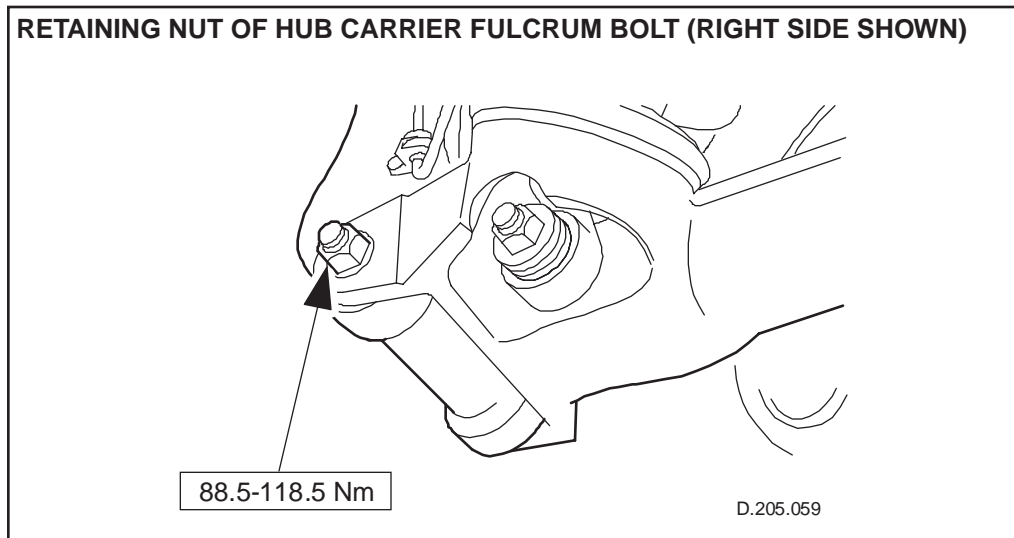
ILLUSTRATION 1

1. Raise the vehicle on a lift so that the rear suspension arms are supported while still allowing access to the nut (Illustration 1) and also to the head of the fulcrum bolt (Illustration 2).

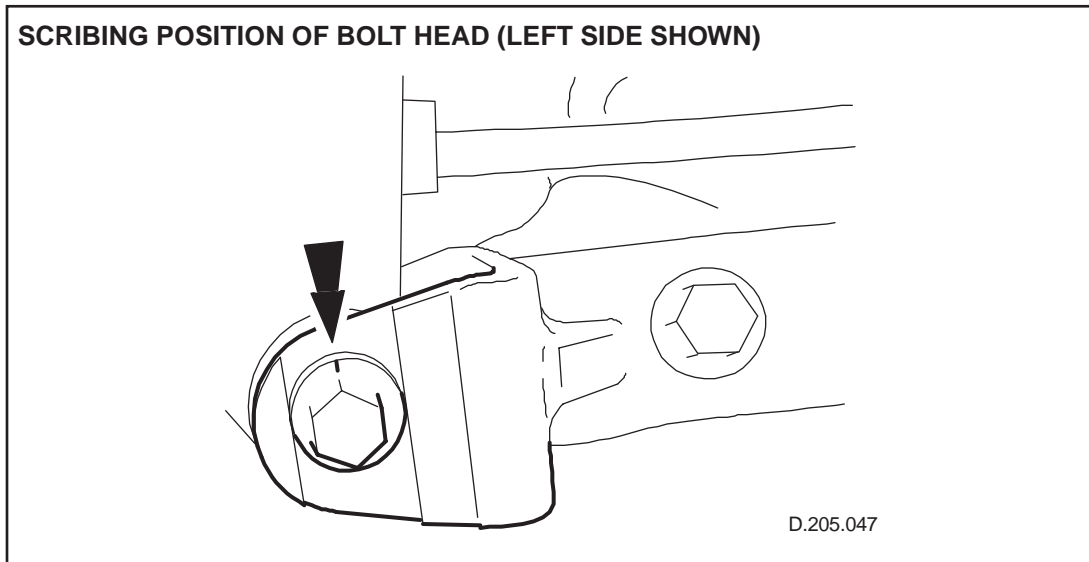
ILLUSTRATION 2

2. Remove the rear road wheels.
3. If necessary, clean the head of each fulcrum bolt so as to be able to identify the marker line stamped on the head of each bolt (Illustration 2). Use a fine-pointed scribe to mark on each wishbone the location of the marker line, prior to dismantling. The marker line will not necessarily be in the location illustrated, depending on previous adjustment to effect correct wheel alignment.

6. While still supporting the hub carrier in position, install the replacement bolt from the rear. Rotate the bolt as necessary to allow the eccentric head of the bolt to fully seat in the guide slot in the wishbone. Align the marker line on the head of the bolt with the line previously scribed on the wishbone in step 3. Install the washer with a **new** self-locking nut, and tighten until the bolt begins to grip, ensuring that the marker line on the bolt head remains aligned to the scribed line.
