Oil Leak – Pinion Oil Seal – Replace Pinion Drive Flange/Oil Seal Assembly – Procedure Not In Workshop Manual

MODEL
 1997 MY-ON XK8 Range
 1998 MY-ON V8 Sedan
VIN
 001001-ON
 812256-ON

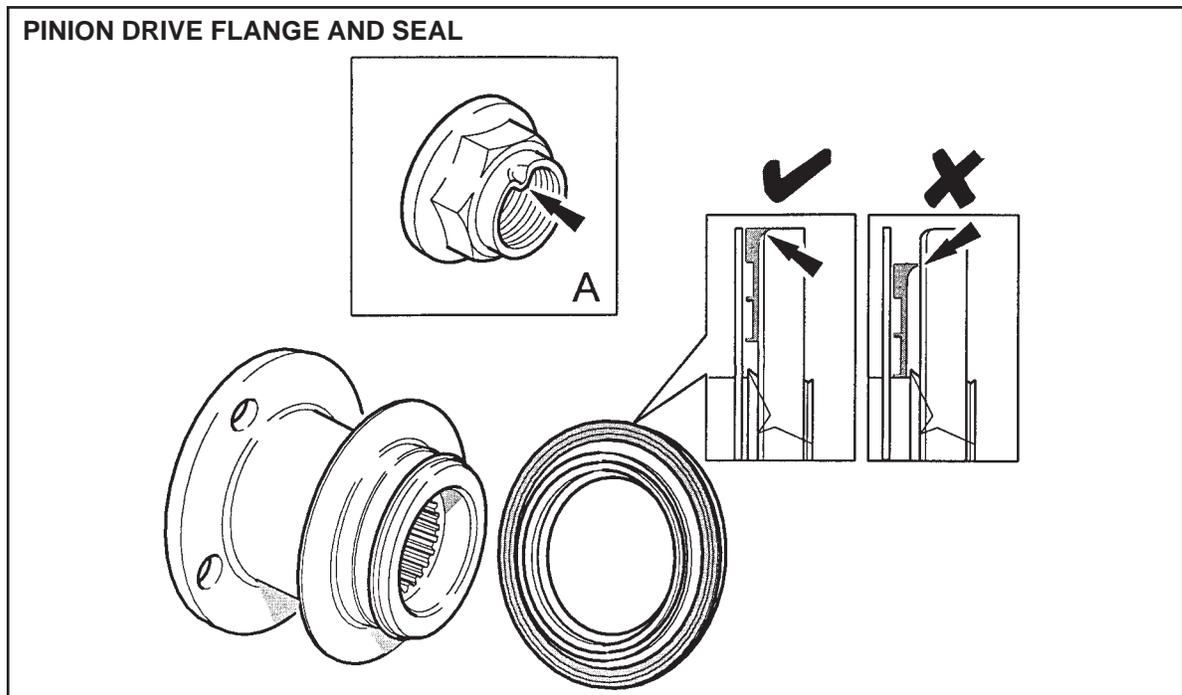
ILLUSTRATION 1

The differential pinion oil seal is manufactured as an assembly with the pinion drive flange and must be replaced as an assembly. This bulletin provides the procedure.

Note: In Illustration 1, the inset with the check mark shows the proper location of the Ryton ring between the seal and the seal flange. The Ryton ring should be concentric with the seal and the lip on the ring should overlap the edge of the seal. The inset with the X shows the incorrect location of the Ryton ring, i.e. not concentric with the seal and resting on the integral seal sleeve. The Ryton ring **MUST** be handled carefully, as it is easily damaged. If the ring is allowed to drop out of position it can be broken when the seal is inserted into the housing.

3. Rotate the pinion coupling until the machined slot in the threaded nose of the pinion, and the depressed area of the coupling retaining nut locking collar (A, Illustration 1), are accessible.

4. Using a punch, preferably with a square section nose to fit into the slot, drive the depressed part of the nut collar out of the slot.
5. Place Special Tool 205-053 (18G-1205), Drive Shaft Flange Wrench, on the coupling to prevent rotation and then, using a socket wrench, loosen and remove the coupling retaining nut.
6. Remove Special Tool 205-053 (18G-1205) from the coupling
7. Install Special Tool 100-005, puller, to the coupling, apply the center screw to the pinion nose and then rotate the screw to withdraw the coupling.
8. Remove the Special Tool and discard the coupling/seal assembly.
9. Clean the seal housing area in the differential case.
10. The coupling/seal assembly, shown in Illustration 1 consists of the following:
 - Coupling with integral seal sleeve.
 - Ryton ring
 - Oil seal

13. At this point check that the Ryton ring is in the proper location.
14. Position the 205-053 (18G-1205) wrench, on the coupling to prevent rotation and then, using a socket wrench, lightly tighten the nut until the seal begins to enter the housing.

15. Before proceeding check that the Ryton ring is still in position against the seal and not protruding.
16. Tighten the nut, against the wrench, to the torque setting of 203 - 223 Nm (150-164 lb ft).
