DTC P1396 (VVT Solenoid
Malfunction - B bank) –
Diagnosis and Repair

MODEL 1997 MY-ON
XK8 Range
VIN
001001-011682

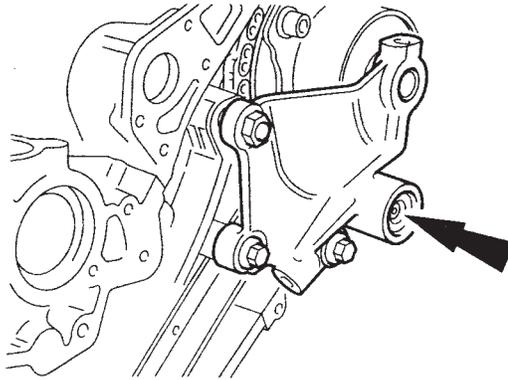
ILLUSTRATION 2

VVT ACTUATING VALVE (SHOWN WITH TIMING COVER REMOVED)

7. Insert a suitable rod through the VVT solenoid mounting opening in the timing cover, into the actuating valve (Illustration 2.)
8. Cover the area surrounding the rod and the timing cover opening with absorbent material to absorb any oil spilled when the engine is run.

9. Start the engine.
10. With the engine at ambient temperature and running at idle, press on the rod to operate the actuating valve, which will in turn operate the VVT actuator. When the engine is cold, the idle speed will become uneven when the VVT operates. This verifies that the VVT actuator operates correctly.

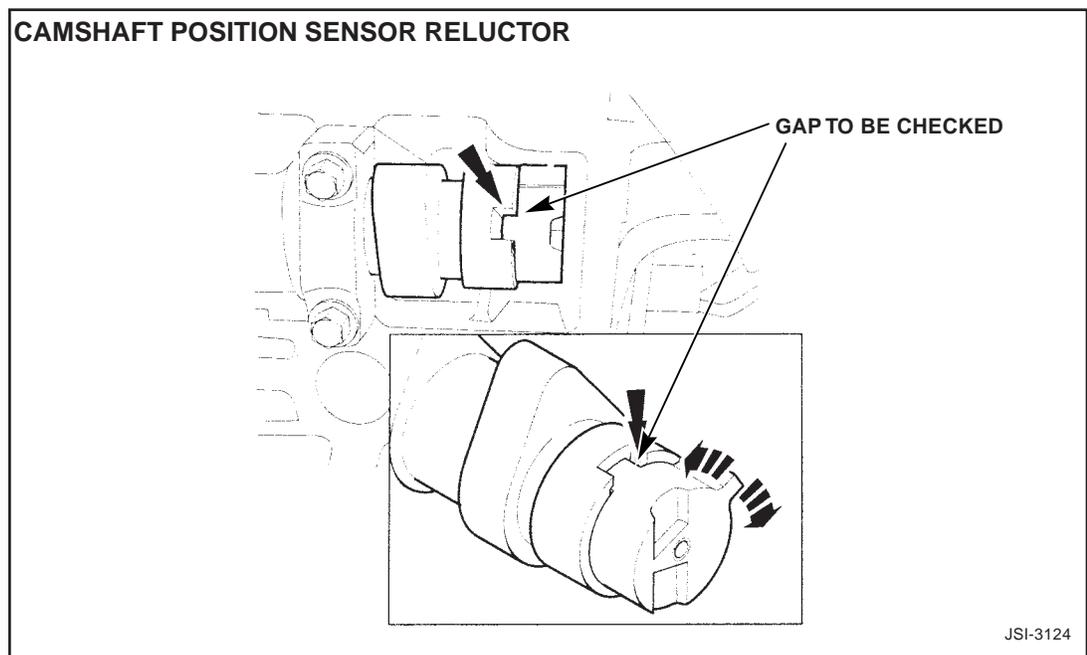
ILLUSTRATION 3

A limited number of engines, in vehicles within the above VIN range, may have a reductor misalignment which would result in DTC P1396 being stored.

7. Remove and discard the outer and inner gaskets from the camshaft cover.
8. Rotate the crankshaft until you can observe the position of the camshaft position sensor reluctor. The reluctor (Illustration 3) should be centered in the drive slot without a noticeable gap at either side. Illustration 3, for example, shows a gap at the arrow meaning that the reluctor is advanced. If the gap were at the other side, the reluctor would be retarded. If the reluctor is not positioned properly, proceed to step 9, otherwise proceed to step 12, then refer to DTC summaries manual for other possible causes for DTC P1396.

9. Use suitable locking pliers to hold the camshaft on the unfinished area between cylinders 3 and 4, at the cast-in flat projection.
10. Lightly strike the reluctor lobe, while tensioning the camshaft in the opposite direction, to re-position the rotor against the opposite face of the slot.
11. Remove the locking pliers from the camshaft.
