V8 XJ Series

303-13

TECHNICAL BULLETIN

Engine Block Heater – Install Power Cord –
Service Action S686 –
Canadian Market Vehicles Only

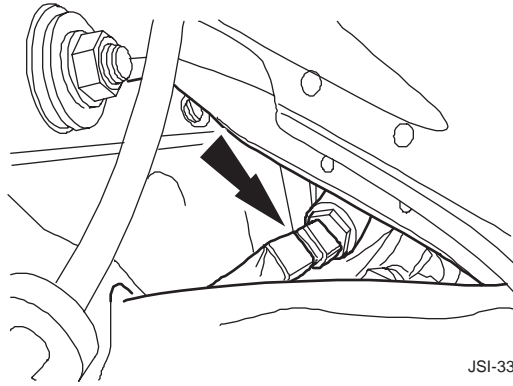
ILLUSTRATION 1

POWER CORD CONNECTED TO BLOCK HEATER

5. Connect the power cord to the block heater, then route the cord downwards and towards the front of the vehicle, as shown in Illustration 1.

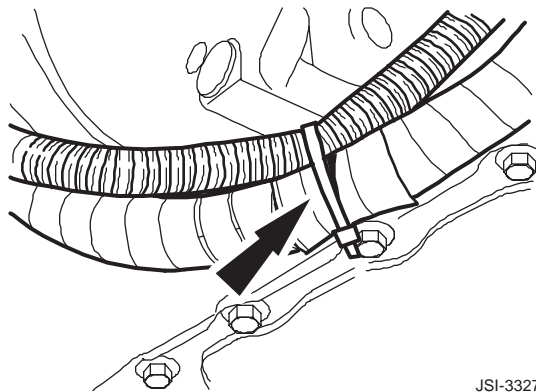
ILLUSTRATION 2

CORD SECURED TO PAS HOSE

6. Pass the power cord forwards and downwards, over the suspension crossmember, so that it can be attached to the power steering feed hose, at the ferrule, using a tie strap as in Illustration 2. Trim off any excess length of tie strap.
