V8 XJ Series/XK8

303-14

TECHNICAL BULLETIN

Low Coolant Level –
Warning Lamp Illuminated

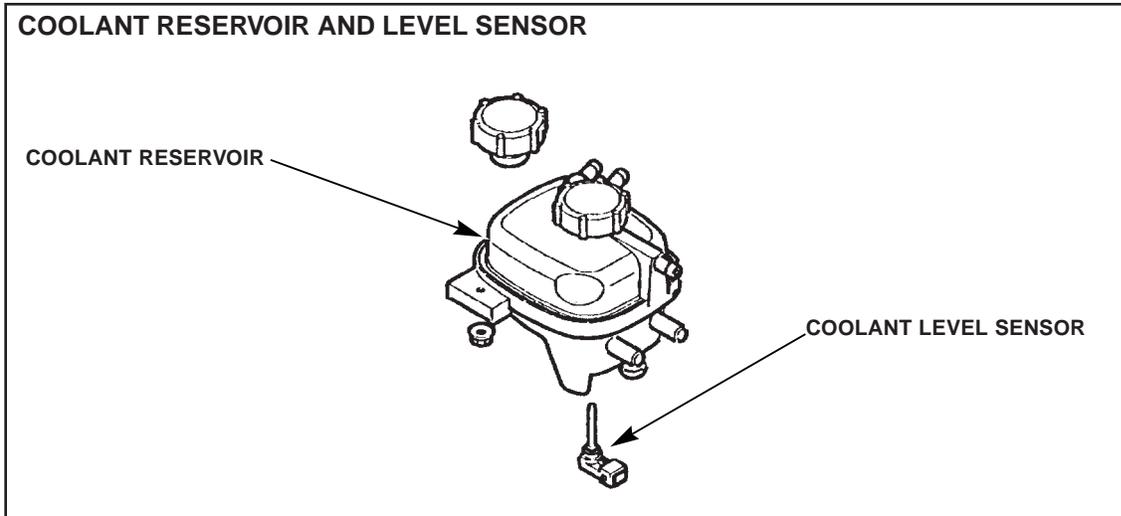
ILLUSTRATION 1

When a new vehicle is factory-filled with antifreeze solution, small pockets of air may remain trapped in the cooling system. On a new vehicle, these pockets of air may take some considerable time to be purged, resulting in a gradual drop in the coolant level. This process may eventually lead to illumination of the coolant warning lamp by the low level sensor located in the coolant reservoir.

Once the coolant level has dropped, it is also possible that the captive float which actuates the low level sensor may stick in the down position, leaving a warning on even after the cooling system has been refilled.

1. With the engine **cold**, remove the pressure cap from the coolant reservoir. Check the pressure cap seal - replace if necessary. Visually check the coolant level. If low, continue with the procedure below.
2. If the coolant level is below the bottom of the filler neck, top up with Jaguar Antifreeze D542 (diluted 50:50 with clean water) until the coolant rises to the bottom of the filler neck.
3. Start the engine and allow it to run at idling speed. The coolant level may fall in the coolant reservoir. With the engine still running, immediately top up the coolant to the bottom of the filler neck.
4. Before the coolant temperature has a chance to increase, fully tighten the pressure cap on the coolant reservoir.
5. Before stopping the engine, check that the coolant warning lamp is off.
