Oil Weep – Rear Face of Cylinder Heads**MODEL**1997 MY-ON XK8 Range
1998 MY-ON V8 XJ Series**VIN**001001-ON
812256-ON**Issue:**

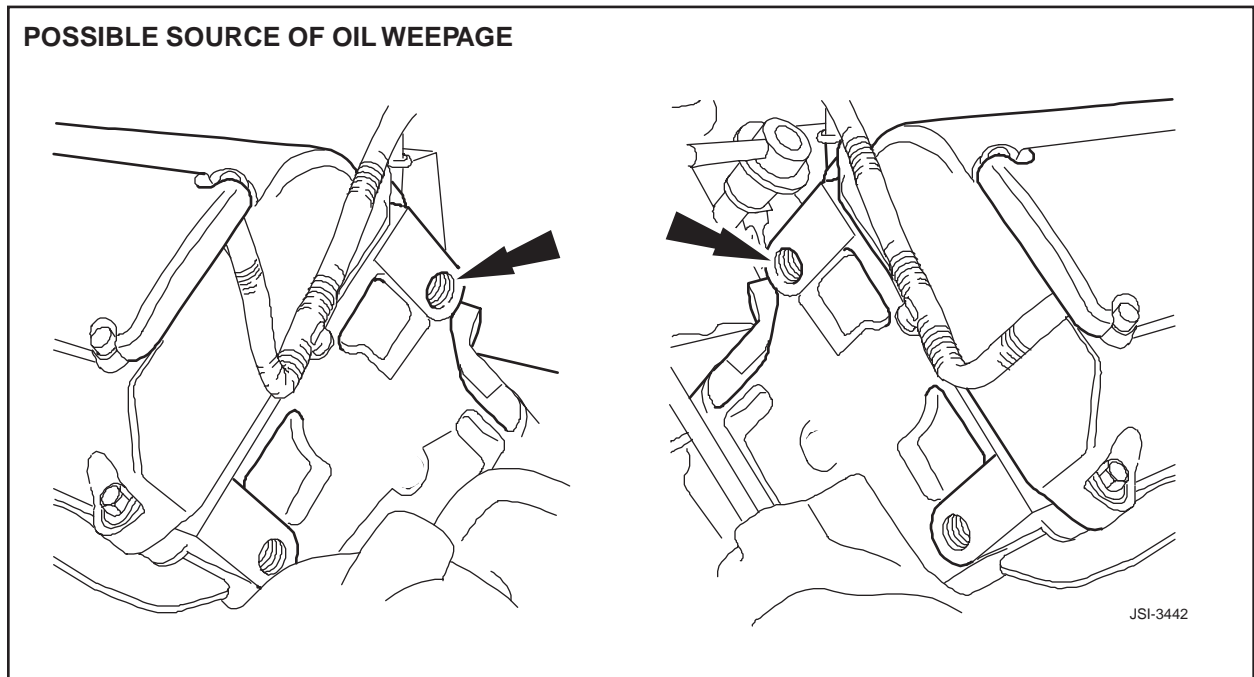
ILLUSTRATION 1

Some vehicles equipped with the AJ-V8 engine may experience oil weeps on the rear faces of cylinder heads. The cause may be oil weeping past a plug which is expanded, during engine manufacture, inside the inner (ie. the hole closest to the center-line of the engine) of the two threaded holes on the back of each cylinder head. These holes (Illustration 1) are also used to install the rear engine lifting brackets.

In case of a customer complaint of oil weepage that is found to come from the rear of the cylinder head, install a “Dowty” oil-sealing washer and bolt in the inner hole as described below. Clean the rear face of the cylinder head before installing the bolt and washer.

Torque: 15 Nm (11 lb ft)
