V8 XJ Series/XK8

303-28

TECHNICAL BULLETIN

Revised Camshaft Drive Operations – Use Ball-ended Hex Drive Bit

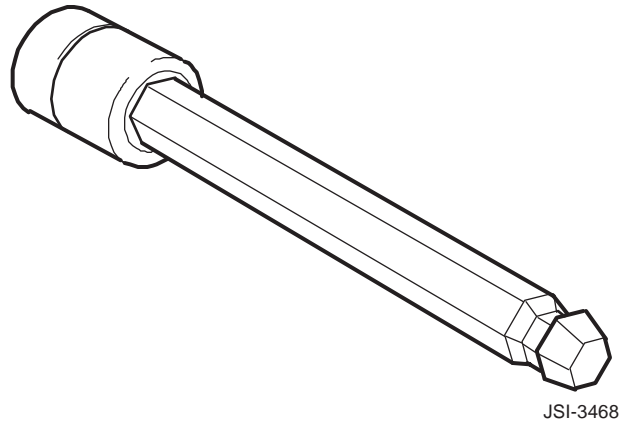
ILLUSTRATION 1

TYPICAL 10MM AF BALL-ENDED DRIVE BIT

Use a 10 mm ball-ended hexagon drive bit, such as Snap-on FABLM10E, or equivalent (Illustration 1), to remove and retorque the retaining bolt of the exhaust camshaft without removing the timing cover (Illustration 2).

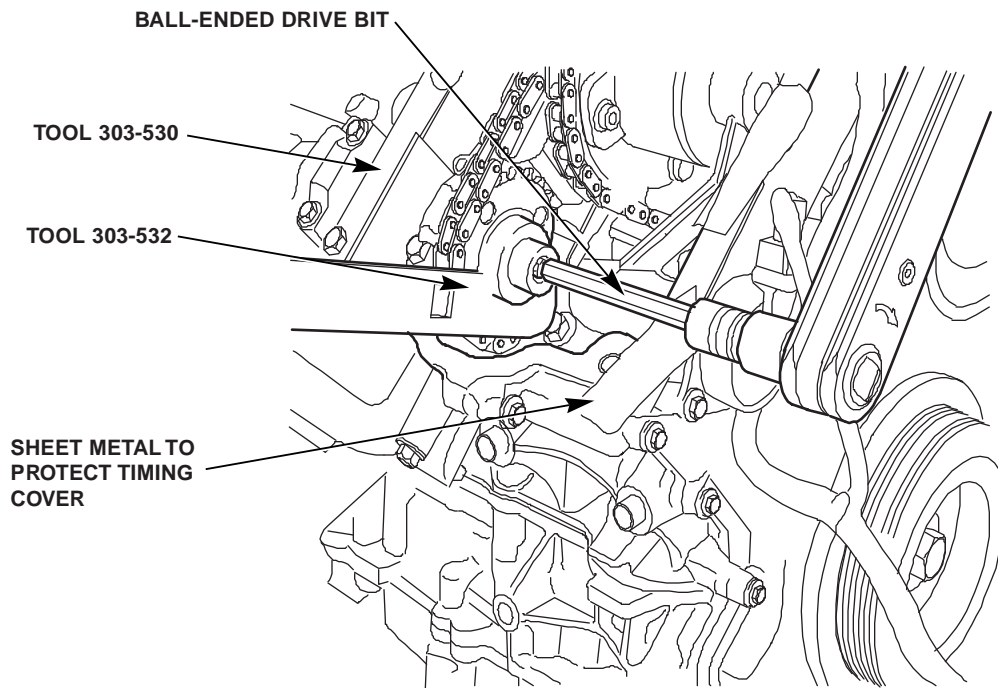
ILLUSTRATION 2

USING BALL-ENDED DRIVE BIT TO REMOVE SPROCKET BOLT

6. Install the camshaft setting tool 303-530 (JD 215) and securing bolts.	AS IN JTIS 4 NO CHANGES
7. Position a length of steel strip (approx 150 x 15 x 3 mm) along the top joint face of the timing cover (Illustration 2) and secure it in position with adhesive tape, to protect the machined upper face of the timing cover from any damage from the use of the ball-end drive bit during following operations. IMPORTANT: IF THE SPROCKET RETAINING BOLT ON THE CAMSHAFT ON THE OTHER BANK OF THE ENGINE IS ALSO TO BE REMOVED OR RETORQUED, MAKE SURE THAT THE STEEL STRIP IS ALSO TRANSFERRED SO THAT THE UPPER MACHINED FACE OF THE TIMING COVER IS ALWAYS PROTECTED WHENEVER THE BALL-ENDED DRIVE BIT IS IN USE.	IMPORTANT CHANGE

8. Apply a Snap-on FABLM10E or equivalent ball-end drive bit and square-drive wrench to the camshaft sprocket securing bolt, loosen and remove the bolt. (See Illustrations). IMPORTANT: DURING THIS AND ANY SUBSEQUENT OPERATIONS ENSURE THAT NOTHING IS DROPPED INTO THE OPEN TIMING CASING. Access is now available for the other listed repair operations that require removing the exhaust camshaft sprocket retaining bolt.	CHANGE AS JTIS 4
