## Noise During Start Up – Install Revised Timing Chain Tensioners

**MODEL**1997-99 MY XK8 Range  
1998-99 MY V8 XJ Series**VIN**Refer to engine  
no. in text**Issue:**

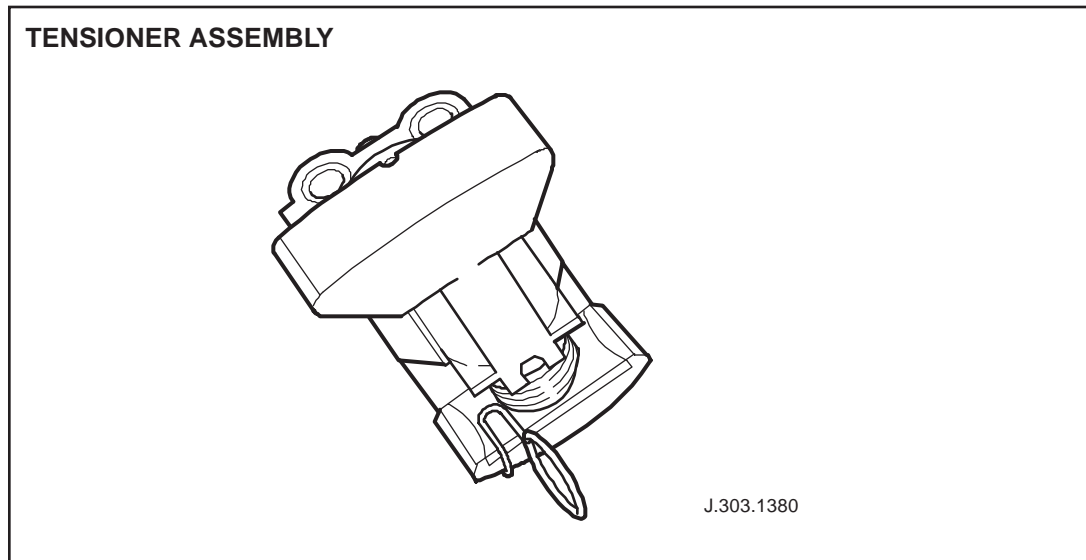
ILLUSTRATION 1

Some vehicles within the above VIN range may experience a rattling noise when the engine is started. This noise may be caused by the secondary timing chain tensioners. Research has shown that a noise can originate at the chain tensioners to cause a resonance in another part of the engine.

- The revised tensioner has a coil spring that presses on the piston head to provide a damping effect.
- To simplify the installation of the tensioner on the engine, a clip (shown in Illustration 2) is provided to hold the piston in a partly compressed position during assembly.

In case of a customer complaint of start up noise, determine if the noise is caused by the secondary timing chain tensioners. If the secondary timing chain tensioners are the cause of the noise, they should be replaced by the revised tensioners (Illustration 1).
