XK8

303-36

## TECHNICAL BULLETIN

Removing Redundant EGR Pipe –  
Authorized Modification –  
Service Action S831

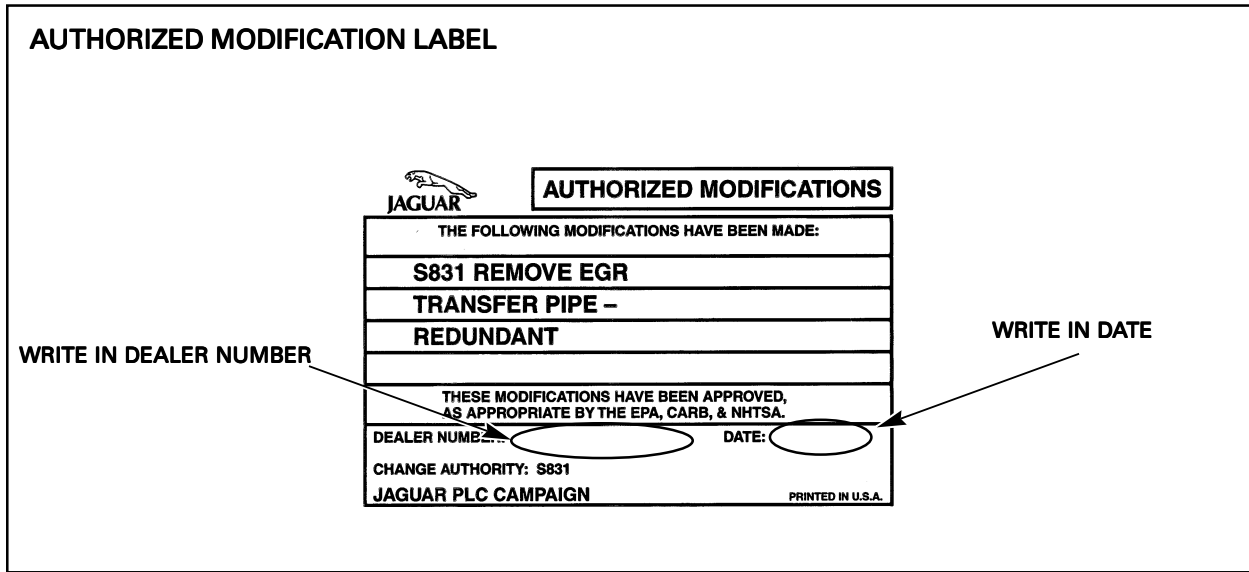
ILLUSTRATION 1

INSTALL AUTHORIZED MODIFICATION LABEL

**Write the date and your dealer number on the S831 authorized modification label (Illustration 1).** Apply the label to the B-pillar on XK 8 vehicles. (This label will immediately indicate to any other dealer that the vehicle concerned has already been rectified). Do not cover or remove any stickers referring to Reflash modifications.

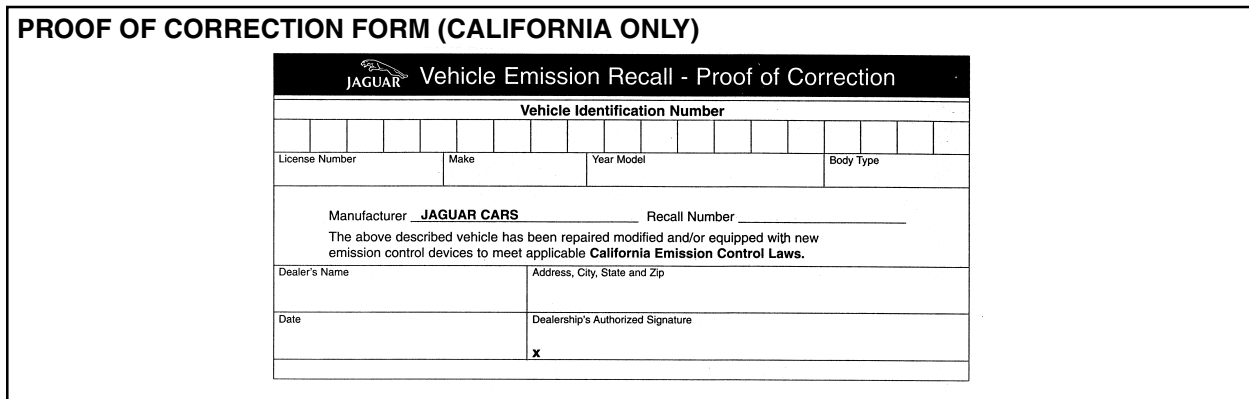
ILLUSTRATION 2

**California Dealers:** Fill out and place the salmon colored “Vehicle Emission Recall - Proof of Correction” form (Illustration 2, part no. S CAL/RCL) in the vehicle glove compartment.
