V8 XJ Series/XK

303-S498

TECHNICAL BULLETIN

**“Engine Fail Safe” Displayed –
Replace Throttle Body – Normally Aspirated
Vehicles Only – Service Action S498**

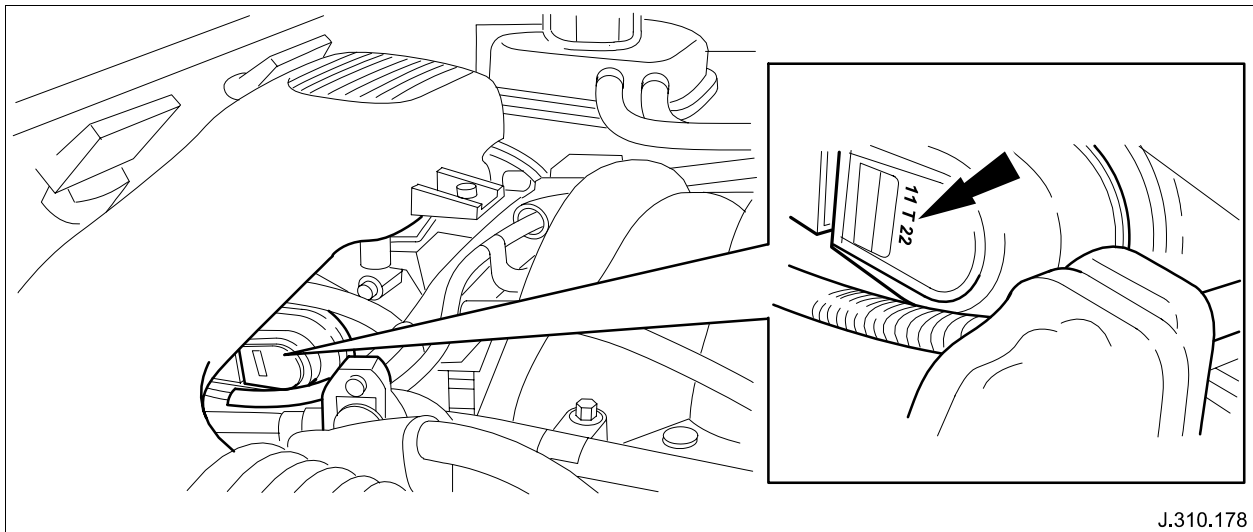
Illustration 2

3. Check date code of the throttle position sensor (Illustration 2).

Note: If the date code is within the range 10T5 to 11T25 inclusive, the throttle body must be replaced, proceed to step 4 of this workshop procedure. If the date code is not within the range 10T5 to 11T25 no further action is required. Proceed to step 34 of this workshop procedure.
