**Check Engine MIL Illuminated/Excess Engine Noise – Replace Cracked EGR Transfer Pipe – Service Action S701**MODEL 1998-99 MY  
XJR

VIN 812256-878717

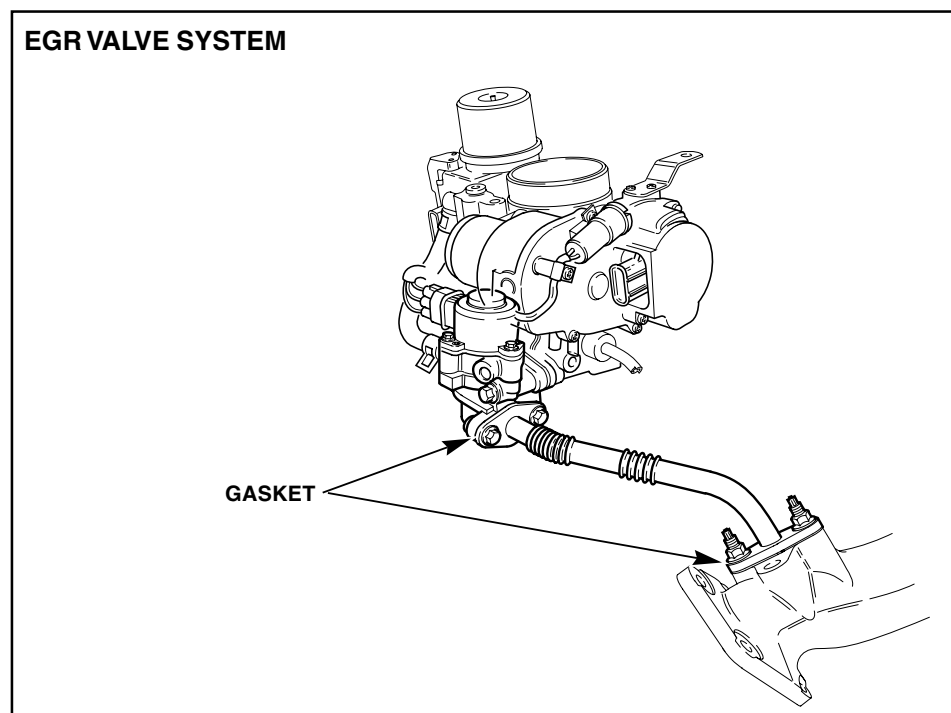
ILLUSTRATION 1

Some 1998-99 MY XJR vehicles within the above VIN range may experience illumination of the check engine light and/or customer complaints of excess engine noise. This condition can be caused by a cracked EGR transfer pipe.

1. Open the hood and place covers over the fenders.
2. Remove the air intake duct, mass air flow sensor, and air cleaner as an assembly.
3. Loosen and remove the bolts securing the EGR transfer pipe to the EGR valve (Illustration 1).
