V8 XJ Series/XK8

600-03

TECHNICAL BULLETIN

Part-Load Engine Breather – Partial Blockage of Restrictor – Scheduled Cleaning – Service Action S474 MODEL 1997-2001 MY XK8 Range 1998-2001 MY V8 XJ Series VIN 001001-**A13614** 812256-**F25708**

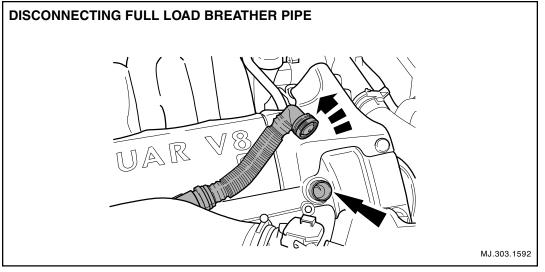
ILLUSTRATION 1

- 4. Disconnect the full load breather line on the right camshaft cover, (Illustration 1).
- 5. Hold a small piece of paper (approximately 60mm x 60mm) over the breather stub pipe. If the paper is sucked to the stub pipe proceed to step 6.

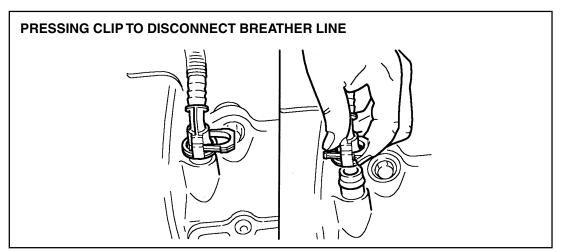
ILLUSTRATION 2

6. Depress the retaining clip (Illustration 2) of the connector of the part-load breather line, allowing the line connector to be disconnected from the breather stub on the left camshaft cover.

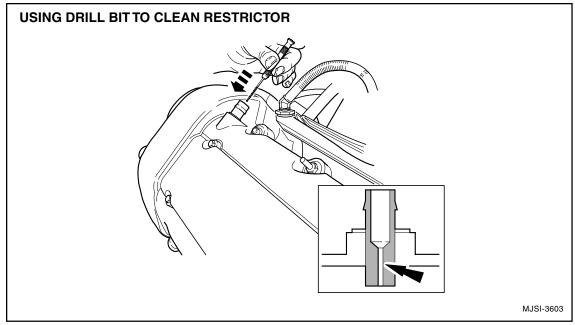
ILLUSTRATION 3

Insert a 3/32" (2.5 mm) diameter drill bit in a hand-held pin chuck such as Snap-on Tools® Part No. YA 806 (Illustration 3). Verify that the drill bit does not exceed 3/32" (2.5 mm) diameter.

8. Carefully push the drill tip into the breather stub and through the restricter while slowly rotating the drill to clear any deposits that may have accumulated inside the restricter. The top end of the restricter is approximately 30 mm below the tip of the line stub and extends for an additional 5 mm into the camshaft cover.
