V8 XJ Series/XK

600-03

**TECHNICAL BULLETIN**

**Part-Load Engine Breather – Partial Blockage  
of Restrictor – Scheduled Cleaning –  
Service Action S474**

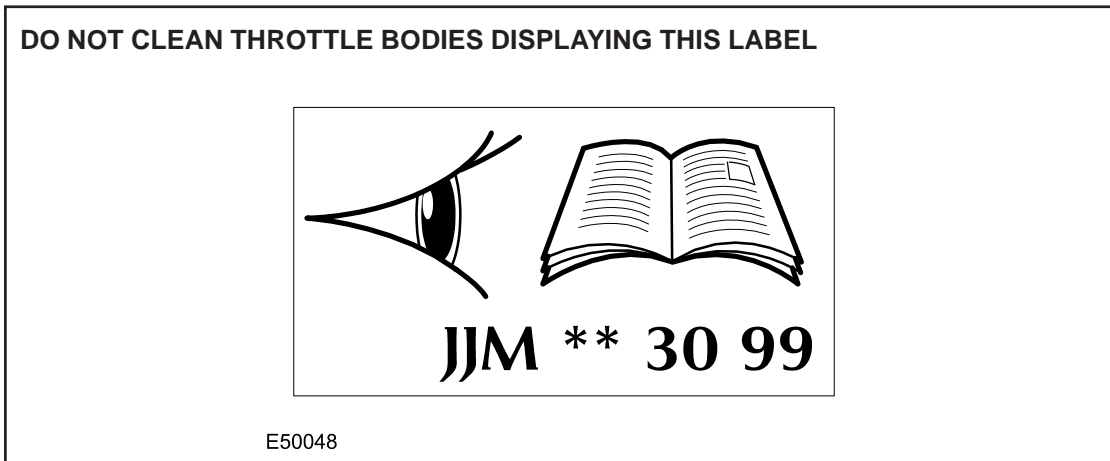
ILLUSTRATION 2

**⚠ Caution:** If the throttle body displays the label shown in Illustration 2, do not clean the throttle body bore and butterfly valve as damage to the vehicle can result.

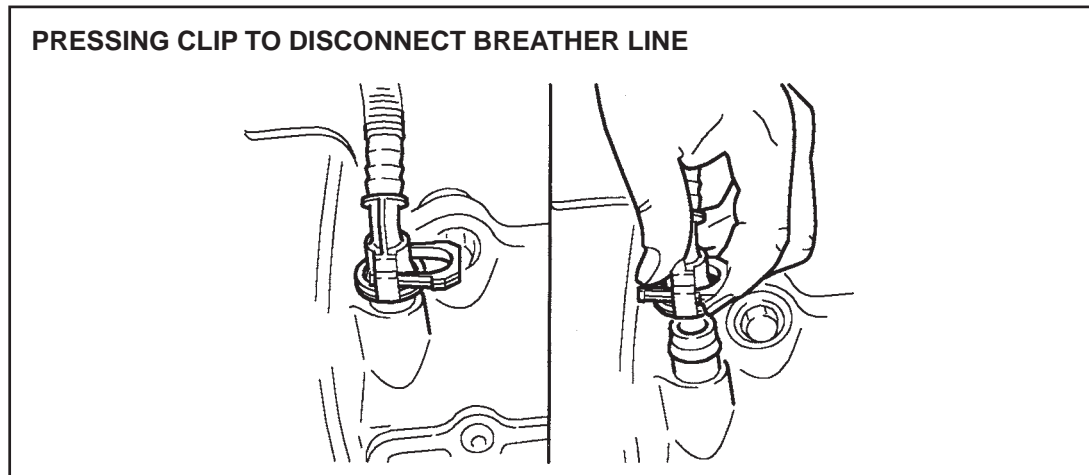
ILLUSTRATION 3

**Note: Failure to clean the throttle butterfly and bore on units without the label may result in engine start/driveability issues.**

6. Depress the retaining clip (Illustration 3) of the connector of the part-load breather line, allowing the line connector to be disconnected from the breather stub on the left camshaft cover.
