Rattle – Rear of Vehicle Underbody –  
Repair Procedure

1997-99 MY XK8 Range  
1998-99 MY V8 XJ Series

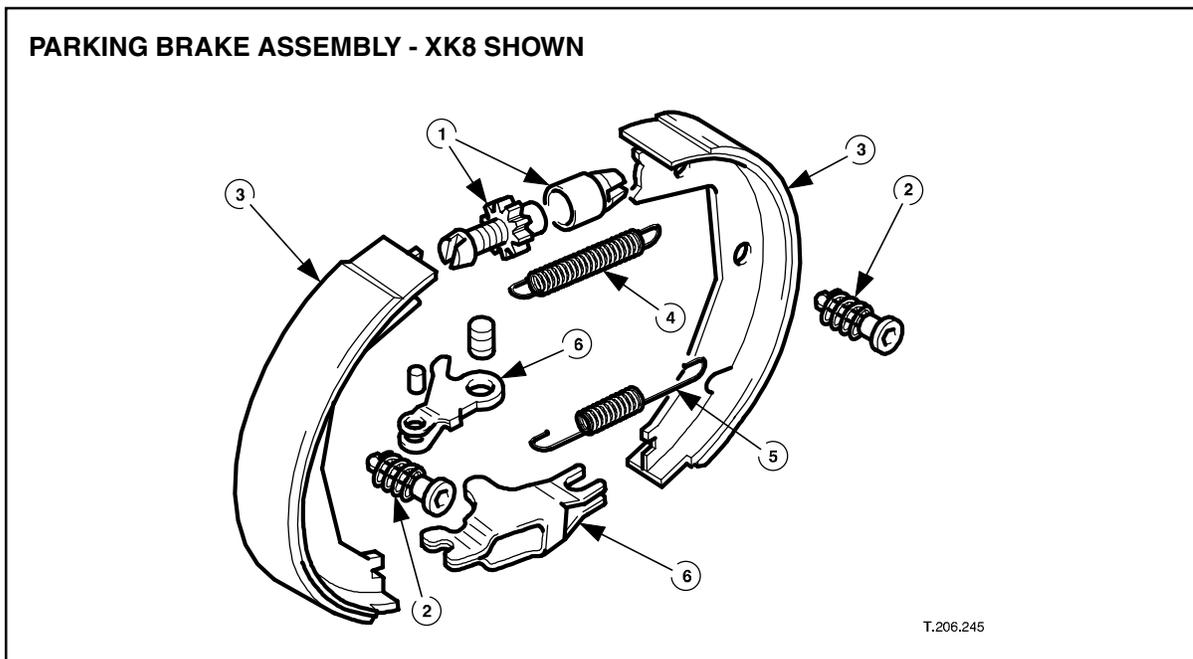
ILLUSTRATION 1

On 1997-99 MY XK8 or 1998-99 V8 XJ Series vehicles, within the above VIN ranges, a rear-end underbody rattle may be caused by the parking brake mechanism.

The concern is more likely to be noticed on an XK8 Convertible model being driven with the convertible top in the down position, rather than on XK8 Coupes or V8 XJ Series Sedans.

Install rubber sleeves over each parking brake shoe lower return spring (Item 5, Illustration 1). The rubber sleeves will exert pressure on the parking brake shoe spreader mechanism, to prevent it from rattling against the backing plate under certain conditions. Sleeves have been installed in production from VINs A00083 and F00035 (start of 2000 Model Year).

1. Raise and support the rear of the vehicle. Ensure that the parking brake is fully released.
2. Remove the rear wheels.
3. Disconnect the rear brake calipers, supporting them clear of the rear brake discs.
4. Without disturbing the adjustment of the parking brake shoes, remove the rear brake discs.
5. Release and remove the lower brake shoe return springs.
6. Slide a rubber sleeve over each spring. (See Parts Information).
7. Reinstall the springs, ensuring that the rubber sleeves are centered on each spring and that the sleeves exert a moderate pressure on the shoe spreader mechanism.
8. Reinstall the brake discs, pads, calipers and road wheels.
