Sedan Range

03.1-04

TECHNICAL BULLETIN

Poor Idle Quality –
Normally Aspirated AJ16 Engine –
Valve Timing Modification

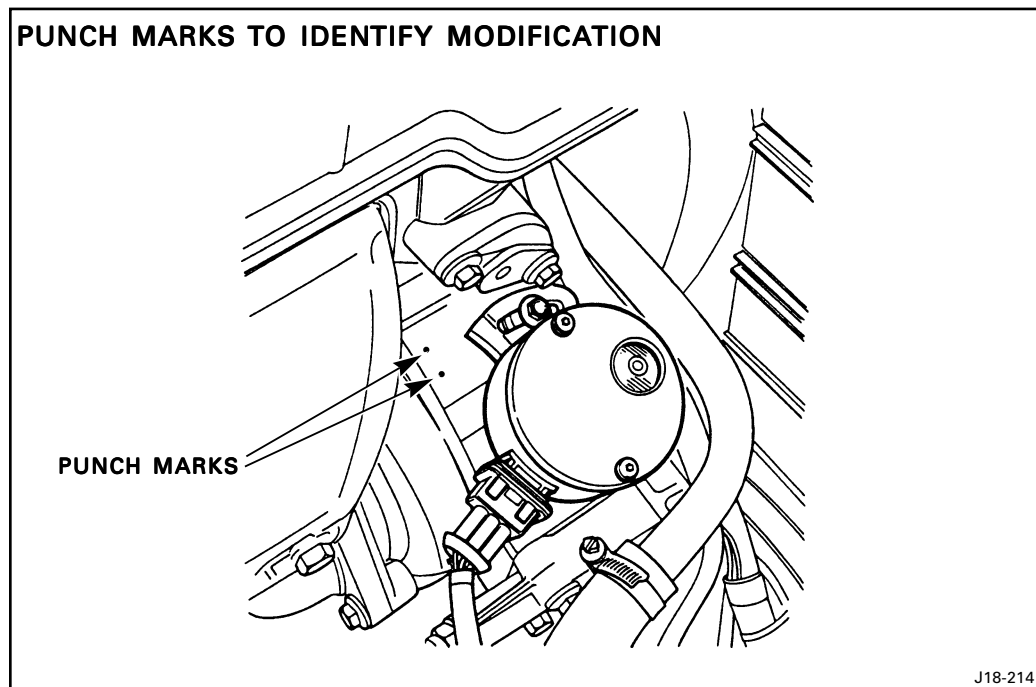
ILLUSTRATION 5

NOTE: Refer to Illustration 5, to identify engines with 110 camshafts that have already been modified.

In case of a customer complaint of poor idle quality on a vehicle equipped with the 110 camshafts only, first check for punch marks on the timing cover near the camshaft position sensor, Illustration 5, to determine if the timing modification has already been performed. If not, reset the camshaft timing and spark plug gap as described below.

33. Place two punch marks approximately 1/4 inch apart on the timing cover parallel to the lip, Illustration 5, to indicate that the modification was done.
34. Connect the battery negative cable and reset the clock.
