Sedan Range

03.1-04

TECHNICAL BULLETIN

Poor Idle Quality –
Normally Aspirated AJ16 Engine –
Valve Timing Modification

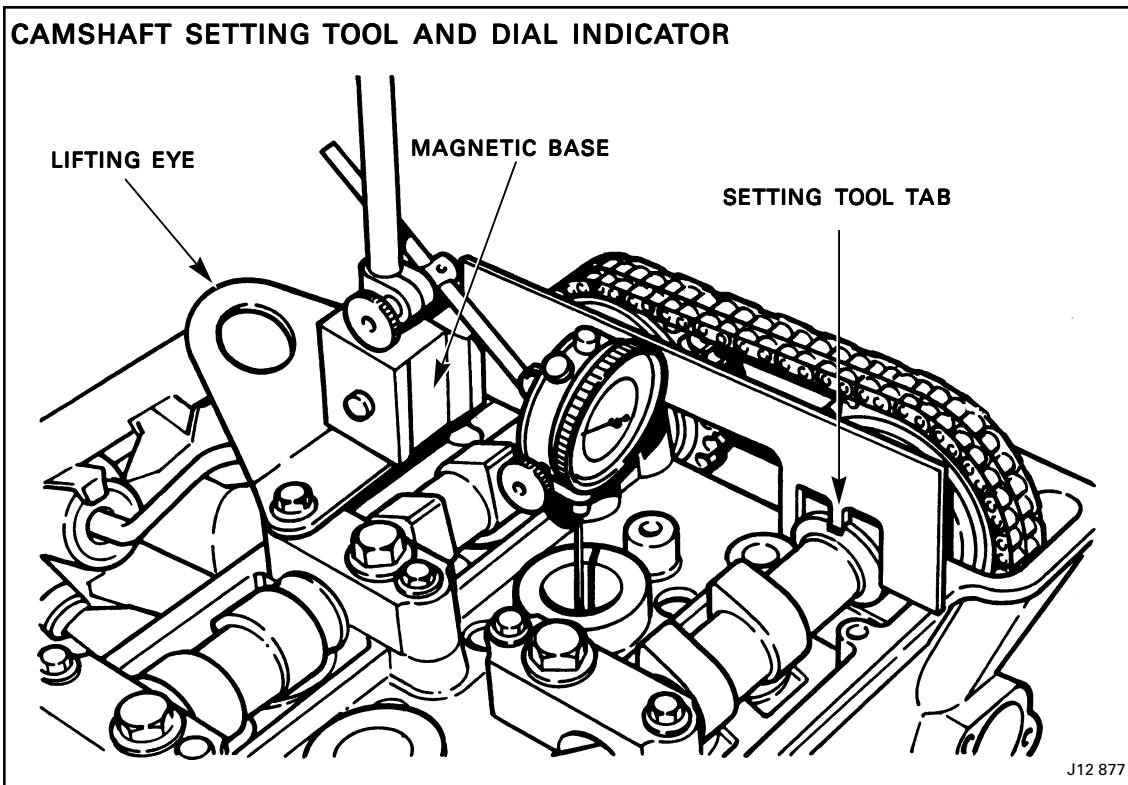
ILLUSTRATION 1

5. Turn the crankshaft until the No. 1 cylinder is at Top Dead Center (TDC) on the compression stroke, i.e. with the cam lobes on the No. 1 cylinder pointing upwards as in Illustration 1. This position can be checked by temporarily inserting the camshaft setting tool 18G-1433/A into the slot on each camshaft.

7. On all engines, attach an engine lifting eye to the intake camshaft cap as shown in Illustration 1.
8. Position the magnetic base of a dial indicator gauge on the lifting eye.
9. Install the dial indicator gauge with an extension pointing downward, into the spark plug bore, contacting the top of the piston.
10. Bend back the locking tabs that lock the bolts holding the camshaft sprocket vernier couplings to the camshafts. Loosen the bolts slightly, but do not remove them.
11. Remove the camshaft setting tool. Rotate the crankshaft back and forth slightly across the TDC position to determine the true TDC point for the no. 1 piston and then zero the gauge.

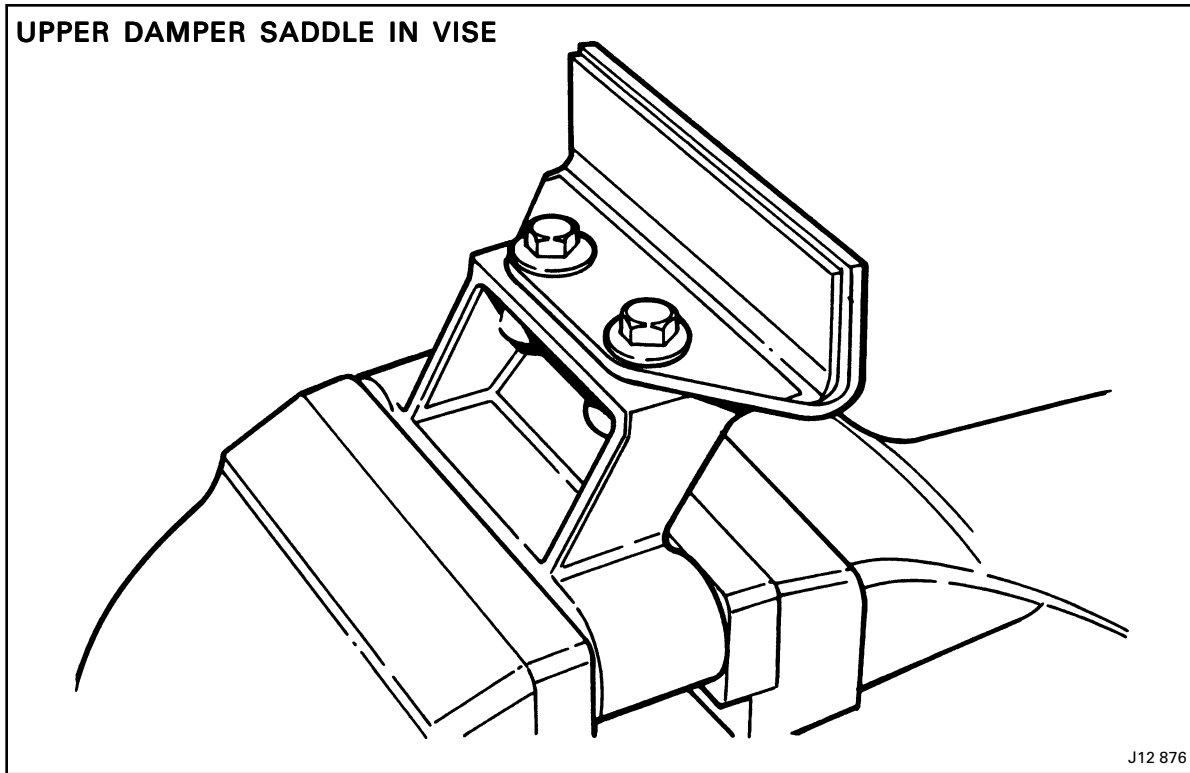
ILLUSTRATION 4

NOTE: Engines starting with 9L103934 (XJS Range) or 9J103935 (Sedan Range) do not require modification since the damper saddles are equipped with self locking bolts.

28. Remove the setting tool, the dial indicator gauge, and the lifting eye. Torque camshaft bearing cap bolt to 12.5 - 16.9 lb ft (17 - 23 Nm).
29. On engines with numbers below 9L103934 (XJS Range) or 9J103935 (Sedan Range) only, remove the damper saddle retaining bolts, Illustration 4. Thoroughly degrease the bolts and the saddle. Apply Loctite 545, part number 54531 to the bolt threads and torque to 15.8 - 21 lb ft (21.5 - 28.5 Nm). Install the damper saddle using new cylinder head bolts and torque to 43.5 - 44.9 lb ft (59 - 61 Nm) plus 90 degrees as described in section 2.1 of the AJ16 Engine Service Manual.
