Sedan Range

05.1-09

**TECHNICAL BULLETIN**

**Uneven Cold Idle –  
Drivability Enhancements –  
ECM Upgrade**

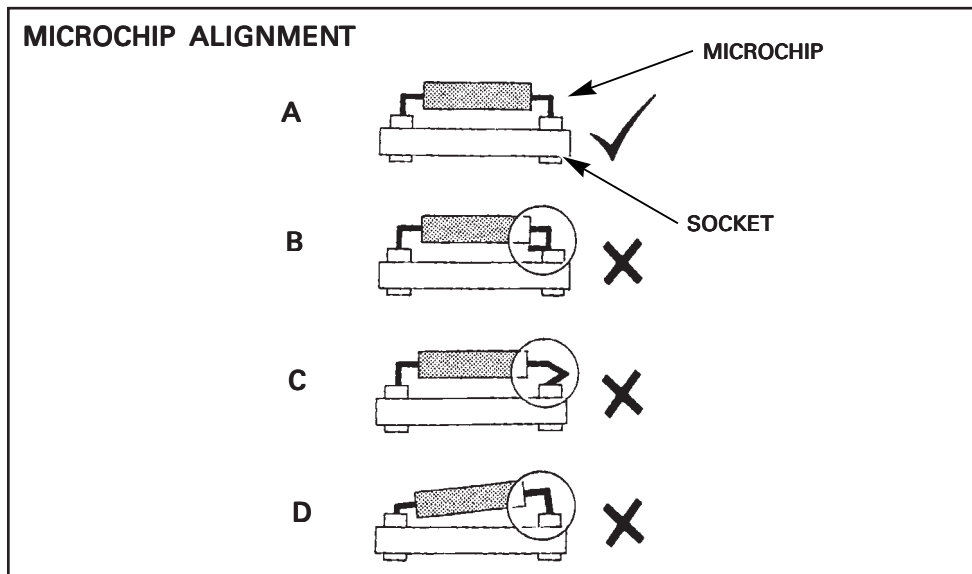
ILLUSTRATION 5

**CAUTION!** The microchip **MUST** lie parallel to the printed circuit board with all the pins engaged into the socket (condition A, Illustration 5). Permanent damage to the chip is likely in conditions B or C. Malfunctions will occur with partial engagement as in condition D.

7. Identify and install the replacement 28-pin chip from the kit into the 28-pin socket and the 32-pin chip into the 32-pin socket.
