DATE 4/95

05.1-12

Plenum Chamber Drain Valve –
Distorted – Water Entering ECM –
Service Action S619

MODEL 1995 MY
Sedan (4.0L) Range
VIN 720001-725767

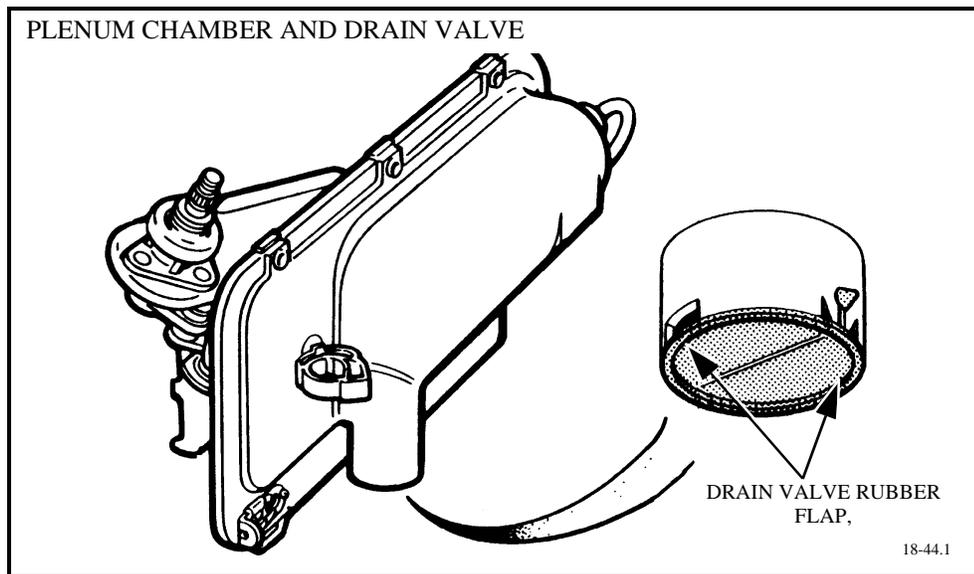
ILLUSTRATION 1

1. Visually inspect the drain valve rubber flap using a light and mirror.
 - If the drain valve rubber flap is in the correct position, as shown in Illustration 1 above, no further action is required.

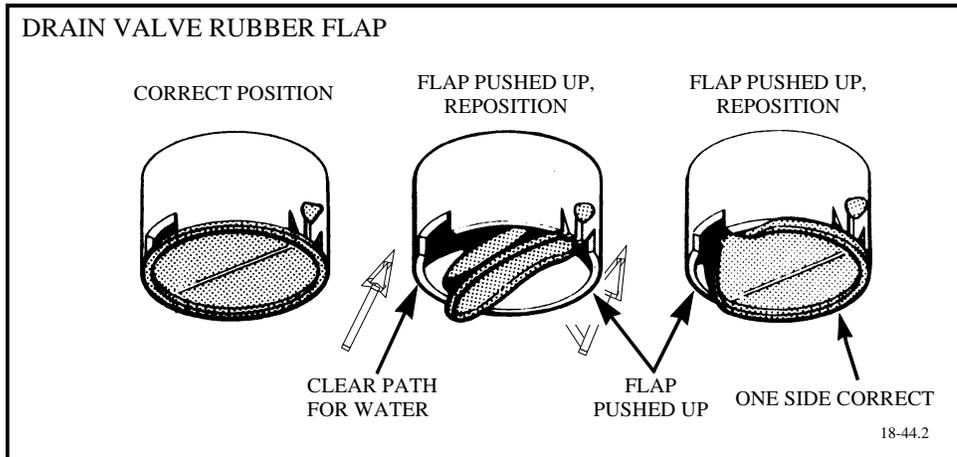
ILLUSTRATION 2

2. If the rubber flap is pushed up, with one side open to allow a clear path for water drain (Illustration 2) or with one side in the correct position, reposition the flap to the correct position with the fingers. No further action is required.

NOTE: The rubber flap must be free from the drain tube walls to allow water to drain.

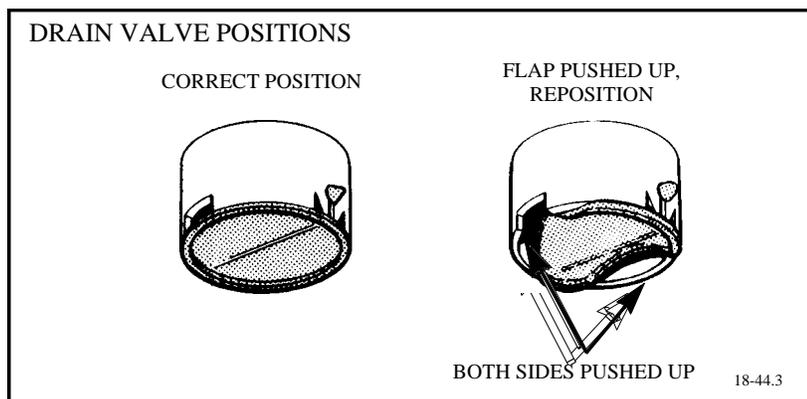
ILLUSTRATION 3

The plenum chamber water drain valve rubber flap may be incorrectly installed in some 1995 MY Sedan Range vehicles from VIN 720001 to 725767. In some cases the rubber flap may restrict the water drain tube causing water to leak down the “A” posts. The leaking water may damage the ECM.

3. If the rubber flap is pushed up into the drain tube, with both sides restricting water flow (Illustration 3), reposition the flap to the correct position with the fingers and check the ECM for signs of water damage.

1. Record all preset radio stations and disconnect the negative battery cable. Remove the lower right side "A" post trim to access the ECM.
2. Remove the ECM and mounting bracket. Disconnect the ECM harness connectors.
3. Examine the ECM for signs of water damage.
 - Look for evidence of water stains or marks
 - Examine the ECM housing, connectors and harness for signs of moisture.

4. If there is any evidence of moisture or previous water leakage in the ECM, connectors or harnesses, replace the ECM.

NOTE: Connectors, harnesses and surrounding areas must be thoroughly dry before a new ECM is installed.
