**TECHNICAL BULLETIN**

Plenum Chamber Drain Valve –  
Distorted – Water Entering ECM –  
Service Action S619

MODEL 1995 MY  
Sedan (4.0L) Range  
VIN 720001-725767

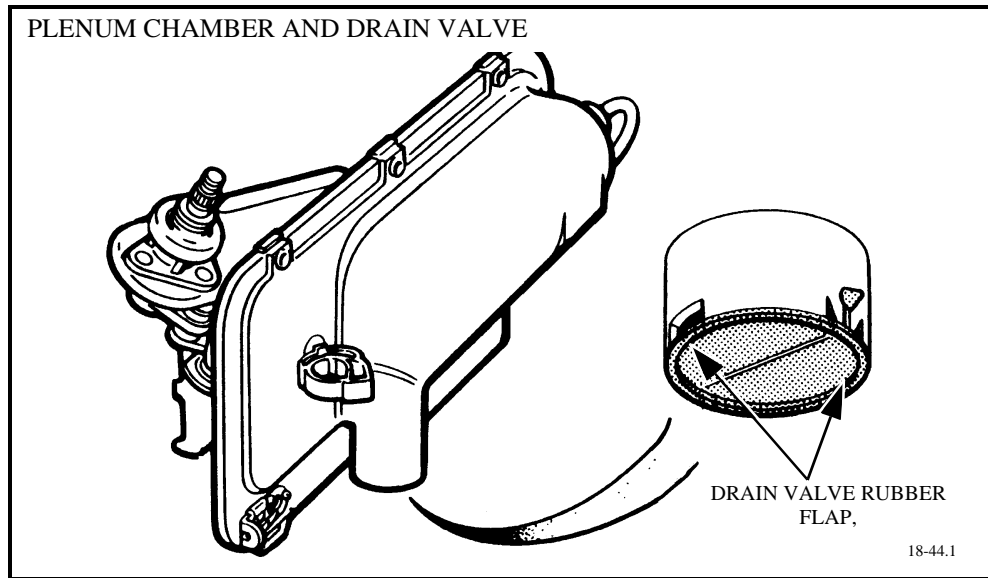
ILLUSTRATION 1

1. Visually inspect the drain valve rubber flap using a light and mirror.
  - If the drain valve rubber flap is in the correct position, as shown in Illustration 1 above, no further action is required.
