DATE 07/00
Amended 08/02

TECHNICAL BULLETIN

Recall T493 - 1995 MY/Recall R493 - 1996-97
MY – AJ16 EGR System –
Replace PROMs and EGR Valve

MODEL 1995-97 MY
Sedan (4.0L) Range
VIN
720001-812255

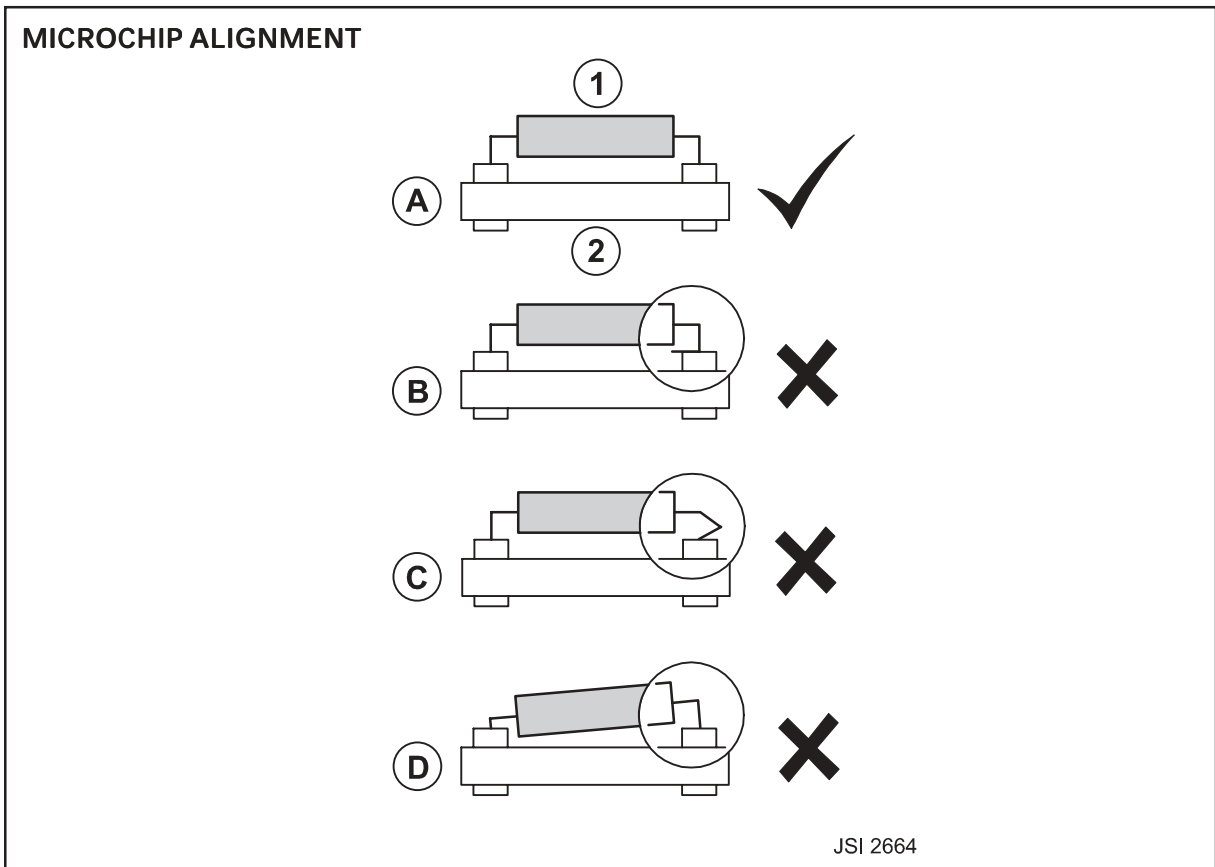
ILLUSTRATION 6

⚠ Caution: Permanent damage to the microchip is likely in conditions B or C. Malfunctions will occur with partial engagement, as in condition D.

12. Use great care to achieve condition '1' in Illustration 6. The microchip must lie parallel to the printed circuit board, with all pins fully engaged into their corresponding locations in the socket.

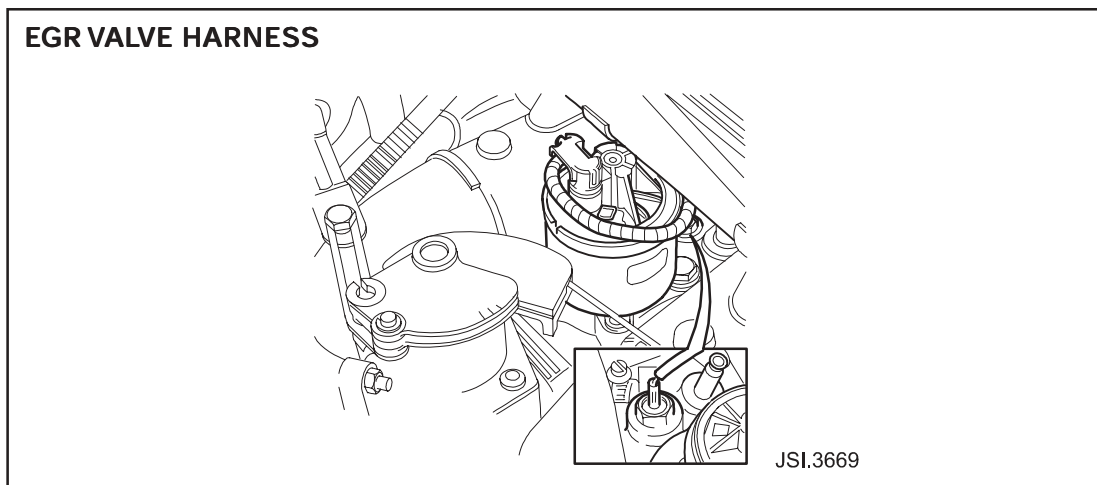
ILLUSTRATION 8

Since the introduction of the AJ16 engine Jaguar has seen a high rate of replacement of EGR valves following illumination of the malfunction indicator lamp (MIL). This is understood to be a result of accumulated contamination within the EGR valve that can produce possible drivability issues such as rough idle, hesitation, and difficult starting.

1. Open the hood and place covers over the fenders.
2. Disconnect the EGR valve harness connector (Illustration 8).
3. Remove the EGR valve securing bolts.
4. Remove the EGR valve and valve gasket.
5. Clean the valve mating faces.
6. To reinstall the new EGR valve and gasket, reverse the EGR valve removal process.

Note: Care must be taken not to damage the EGR valve securing bolts. Torque figure: 23–27 Nm (17–20 lb ft).
