Sedan Range

05.1-31

## TECHNICAL BULLETIN

DTCs P1176, P1177, P1178, P1179 –  
Adaptive Fuelling System –  
Diagnostic Procedure

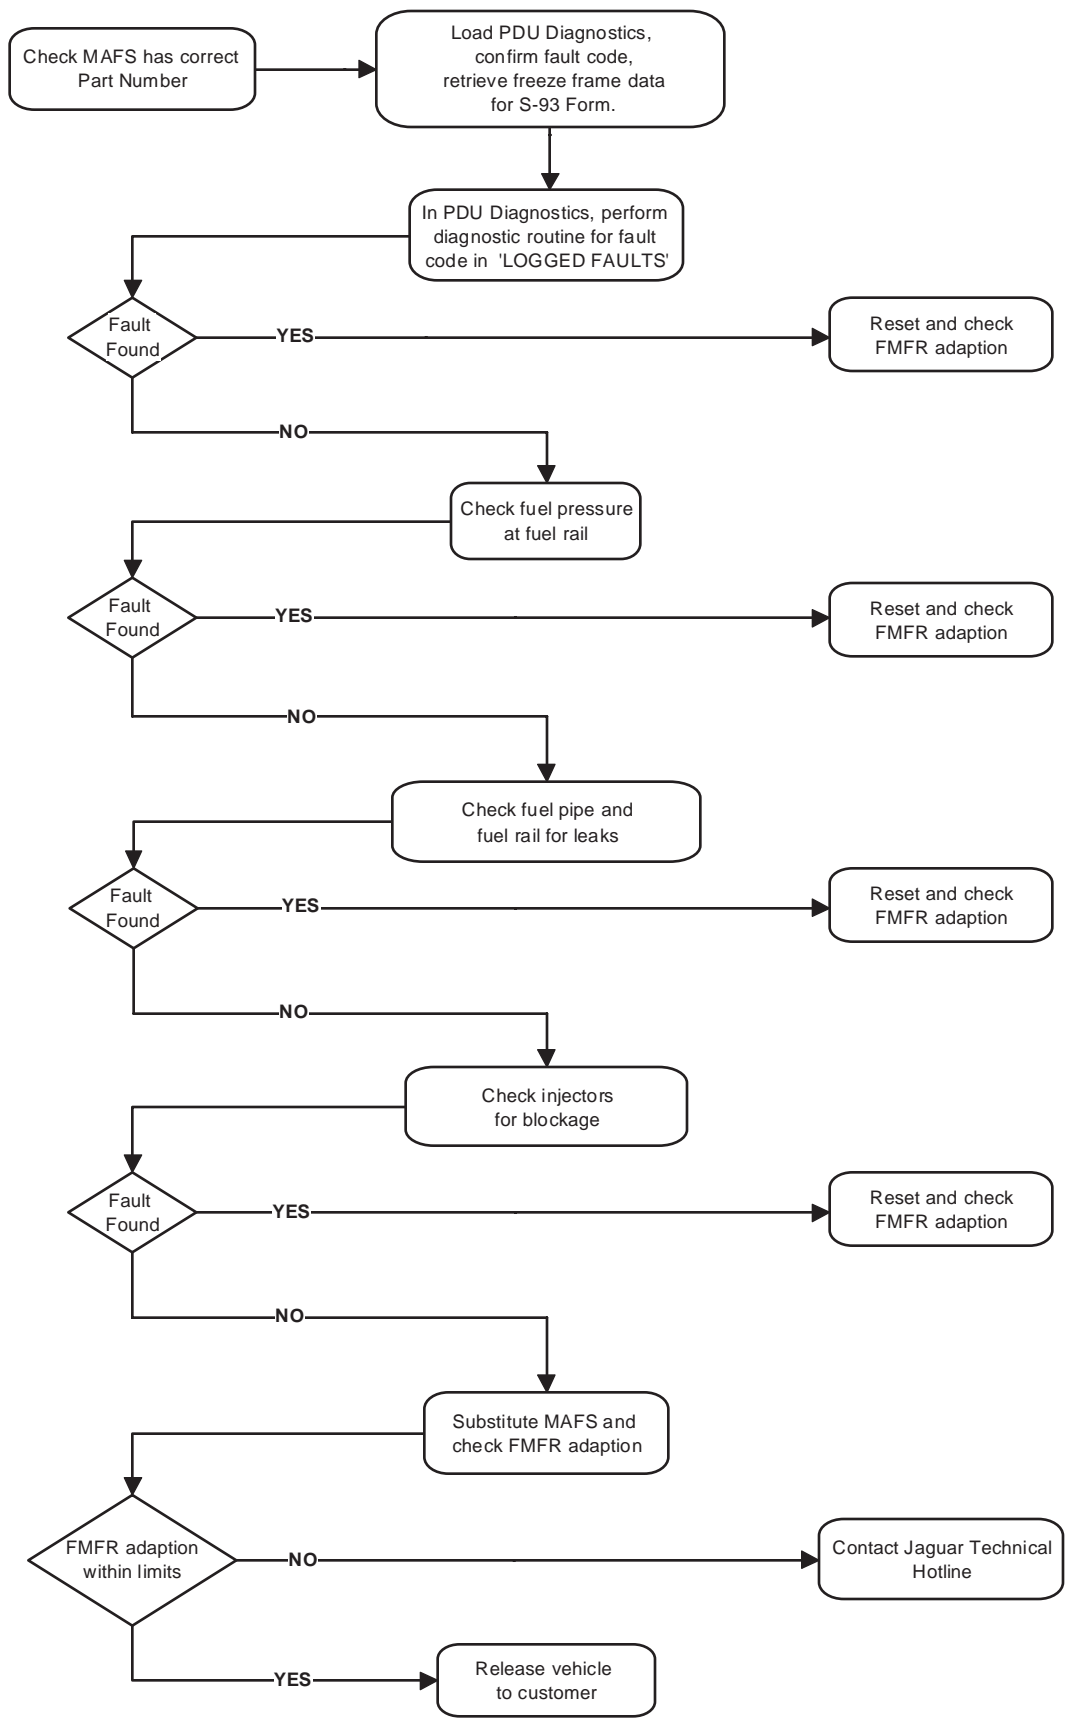
# OBD II - DTC P1176 - lean fuelling trim - long term (FMFR)

The adaptive fuelling system operates within predefined adaption limits to maintain an optimum performance level. Both the Fuel Mass Flow Rate (FMFR) and the Air Mass Flow Rate (AMFR) are monitored by the ECM to ensure they stay within the adaption limits. However, if a fuelling system problem occurs and the adaption limits are exceeded, a Diagnostic Trouble Code (DTC) is then stored in the ECM. The engine Malfunction Indicator Lamp (MIL) will illuminate to report the presence of the DTC. The MIL will stay illuminated until the DTC has been cleared using the PDU.

If one or more of the above DTCs are stored in the ECM, then the PDU should be used to identify and clear the DTC(s). After identifying the DTC(s) use the appropriate diagnostic flow chart to diagnose the fault.

After repairing a fault described in the flow chart, complete the next flow chart instruction to 'Reset and Check AMFR adaption' or 'Reset and Check FMFR adaption' to determine if the fault has or has not been successfully repaired. It is not necessary to check or reset adaptations if no faults are identified. Resetting and checking the AMFR and FMFR adaptations is achieved by following the procedure on page 6.
