Sedan Range

05.1-33

TECHNICAL BULLETIN

**Incorrect Emission Control Label –
Install Revised Label – Canadian Vehicles
Service Action S691**

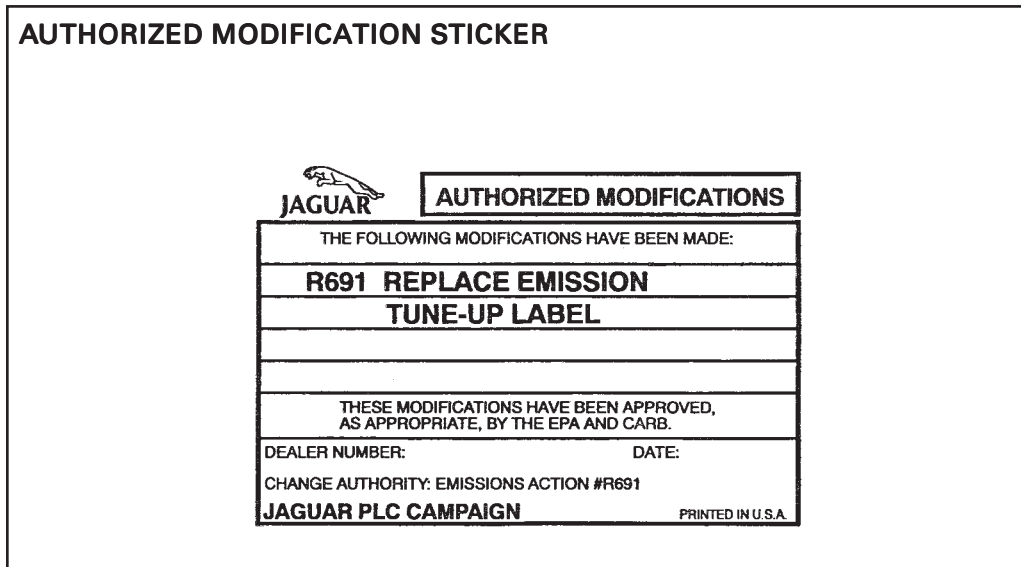
ILLUSRATION 1

1. Check the driver’s door B-pillar area for an R691 authorized modification label used both in Canada, as well as U.S.A. (Illustration 1). If no label is found, continue with step 2.
