Sedan Range

05.2-07

## TECHNICAL BULLETIN

Poor Drivability/MIL Illumination –  
Check Throttle Synchronization

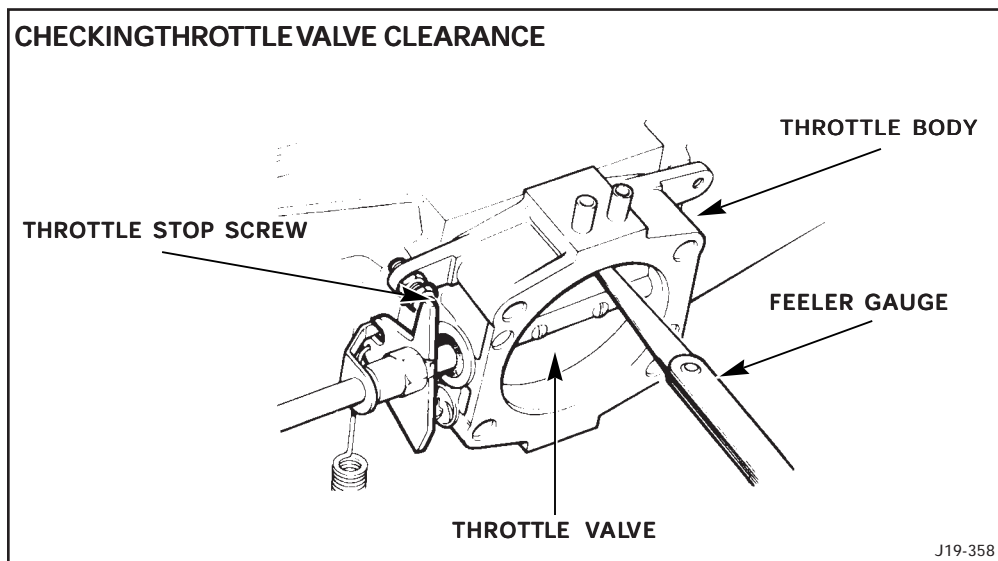
ILLUSTRATION 1

1. Check that both throttle valves are centered horizontally and vertically in the throttle bodies.
2. With the throttle valve closed, use a feeler gauge to check the clearance between the throttle valve and the throttle body (Illustration 1).

Throttle valve checking clearance: 0.001 - 0.003 inch (0.025 - 0.076 mm)

Check the clearance at the bottom as well as at the top of the throttle valve. If a significant difference is found between the top and bottom measurements, the throttle valve may be offset on its shaft. If both measurements are within the above range, do NOT adjust the throttle stop screw (Illustration 1).

3. If adjustment is necessary, set the throttle stop screw to achieve the following throttle valve clearance range:

Throttle valve setting clearance: 0.001 - 0.0015 inch (0.025 - 0.04 mm).

After completing throttle valve adjustment, seal the locknuts with a dab of paint.

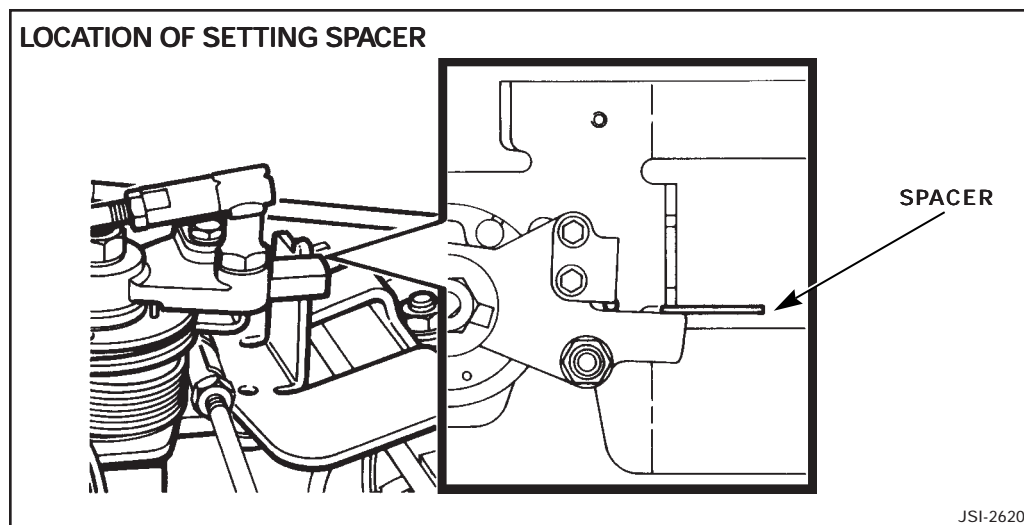
ILLUSTRATION 2

Use the following procedure to obtain the required backlash in the throttle linkage to ensure correct synchronization of throttle opening.

1. Loosen both locknuts on the two linkage rods between the center throttle turntable and the throttle levers.
2. Disconnect one linkage rod from its ball pin on the linkage rod bracket.
3. Position a 0.079 inch (2.00 mm) spacer between the linkage rod bracket and its stop (Illustration 2).

4. Turn the linkage rod that is still connected to increase its length until the throttle lever clears its stop screw.
5. Shorten the linkage rod until the throttle lever just touches its stop screw. Tighten both lock nuts on the linkage rod.

6. Connect the second linkage rod and repeats steps 4 and 5 to adjust its length.
7. Remove the spacer inserted between the linkage rod bracket and its stop.

8. Check the backlash by turning the linkage rod bracket of the throttle turntable slightly clockwise. A gap should appear between the bracket and its stop before either throttle lever leaves its stop screw.  
Gap dimension: 0.062 - 0.094 inch (1.57 - 2.39 mm)

9. Both throttle levers should leave their stops at the same time. Satisfactory synchronization is possible if the second throttle lever moves from its stop after the first throttle lever within a maximum additional increase of 0.030 inch (0.76 mm) in the gap.
