05.2-09

TECHNICAL BULLETIN

**Plenum Chamber Drain Valve –
Distorted – Water Entering ECM –
Service Action S619**

MODEL 1995 MY
XJ12 Sedan
VIN 720001-725767

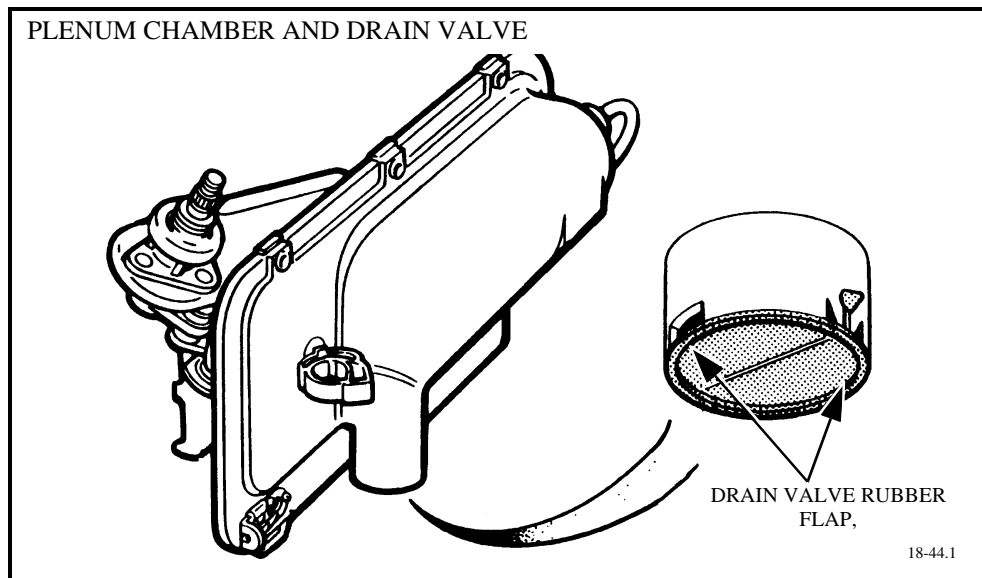
ILLUSTRATION 1

1. Visually inspect the drain valve rubber flap using a light and mirror.
 - If the drain valve rubber flap is in the correct position, as shown in Illustration 1 above, no further action is required.

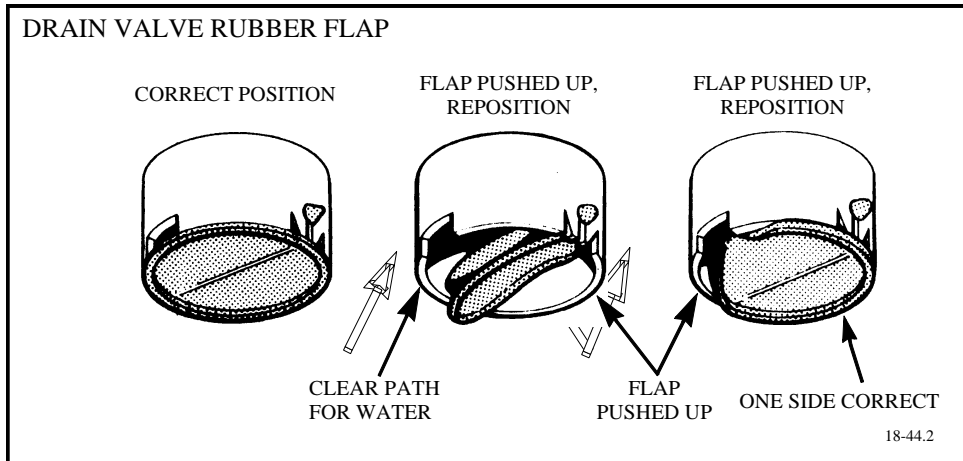
ILLUSTRATION 2

2. If the rubber flap is pushed up, with one side open to allow a clear path for water drain (Illustration 2) or with one side in the correct position, reposition the flap to the correct position with the fingers. No further action is required.

NOTE: The rubber flap must be free from the drain tube walls to allow water to drain.

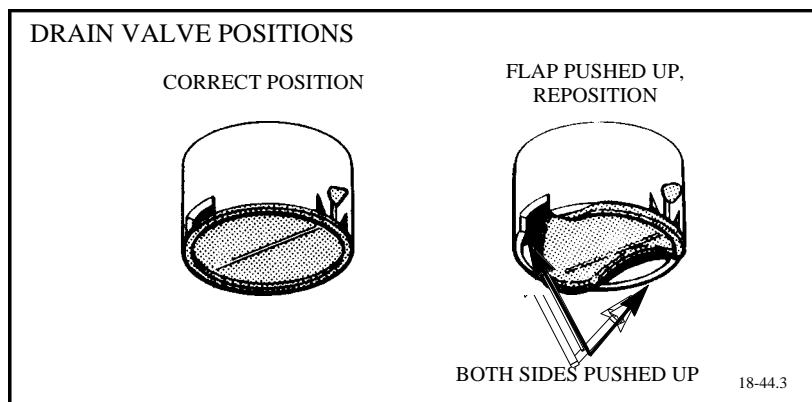
ILLUSTRATION 3

The plenum chamber water drain valve rubber flap may be incorrectly installed in some 1995 MY Sedan Range vehicles from VIN 720001 to 725767. In some cases the rubber flap may restrict the water drain tube causing water to leak down the “A” posts. The leaking water may damage the ECM.

3. If the rubber flap is pushed up into the drain tube, with both sides restricting water flow (Illustration 3), reposition the flap to the correct position with the fingers and check the ECM for signs of water damage.

1. Record all preset radio stations and disconnect the negative battery cable. Remove the lower right side "A" post trim to access the ECM.
2. Remove the ECM and mounting bracket. Disconnect the ECM harness connectors.
3. Examine the ECM for signs of water damage.
 - Look for evidence of water stains or marks
 - Examine the ECM housing, connectors and harness for signs of moisture.

4. If there is any evidence of moisture or previous water leakage in the ECM, connectors or harnesses, replace the ECM.

NOTE: Connectors, harnesses and surrounding areas must be thoroughly dry before a new ECM is installed.
