Sedan Range

08.2-01

TECHNICAL BULLETIN

Transmission MIL Illumination – Revised EPROM – Replacement Procedure

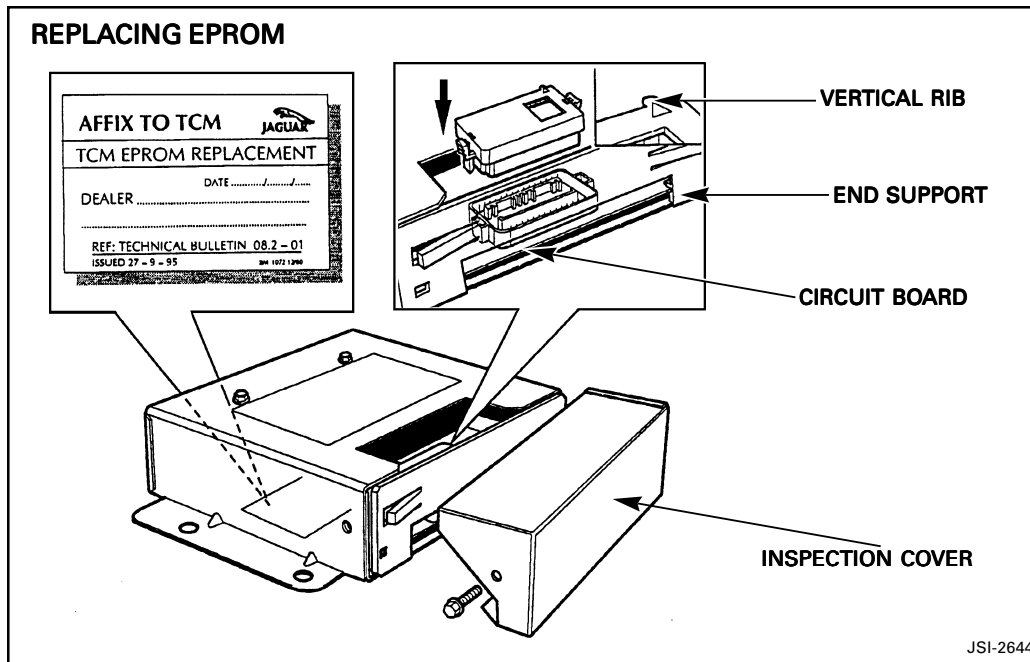
ILLUSTRATION 3

CAUTION! The end support (Illustration 3) is free to move when the inspection cover is removed and must be held in place. Support the circuit board through the opening in the end support to prevent the board from bending and possibly cracking while removing and installing the EPROM.

5. Place the TCM on a clean bench area and remove the TCM inspection cover (Illustration 3).

6. The EPROM has a retaining latch at each end. These latches must be pressed in while removing the EPROM from the socket. Press the latches inward and ease each latch free of the socket. Then, carefully remove the EPROM module from the circuit board.
7. Align the vertical rib (Illustration 3), indicated by an arrow, on the replacement EPROM with the rib on the socket to ensure correct alignment.
