Power Steering System – Revised  
Hose Clips on Reservoir-to-Pump Hose

MODEL 1995-96 MY  
Sedan (4.0L) Range  
VIN 720001-776646

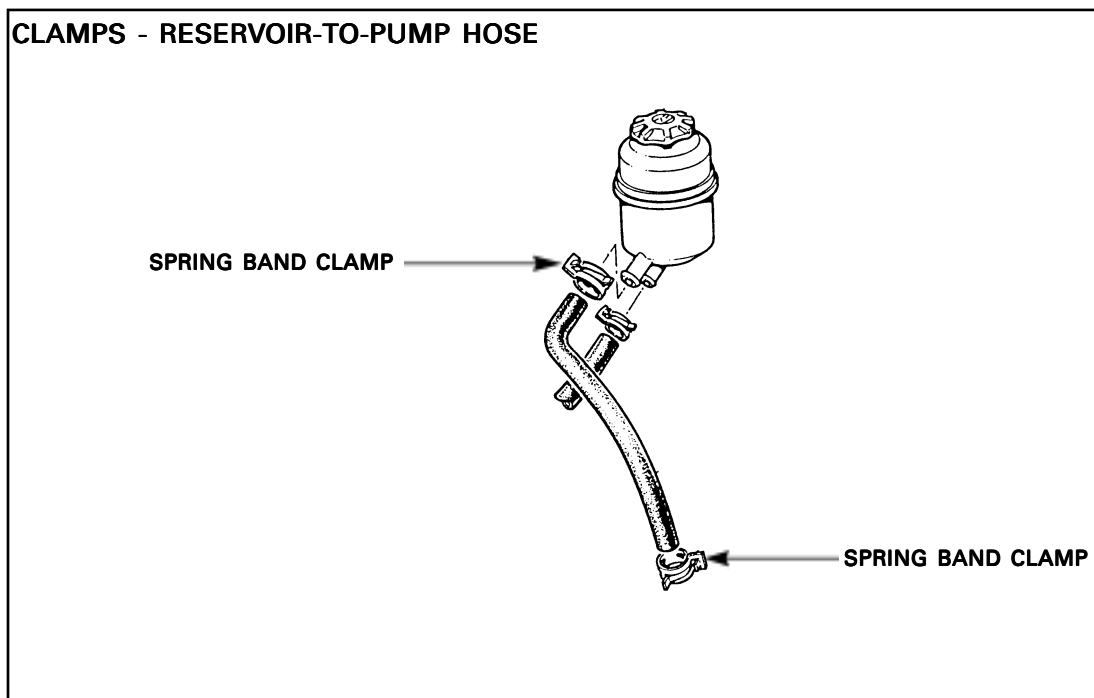
ILLUSTRATION 1

On 1996 MY 4.0L Sedan Range vehicles from VIN 776647, the specification of the hose clamps that retain the hose leading from the power steering reservoir to the power steering pump has been revised.

The spring band style clamp is now replaced by a worm drive clamp at each end of the hose (Illustration 1). This change provides an increase in clamping load, to overcome concerns of hose joint leaks, particularly at the connection to the pump.

Only in the case of a customer complaint of fluid leakage at either point on 1995-96 MY Sedan Range vehicles from VIN 720001-776646, replace the existing spring band clamp with a worm drive clamp (JHC 400401).

Torque the worm drive clamp to 3.5 Nm (31 lb. in.)
