**Steering Rack – Leak at Transfer Pipe
Union Nut – Replace O-rings**MODEL 1995-97 MY
Sedan Range
VIN 720001-812255**ISSUE:**

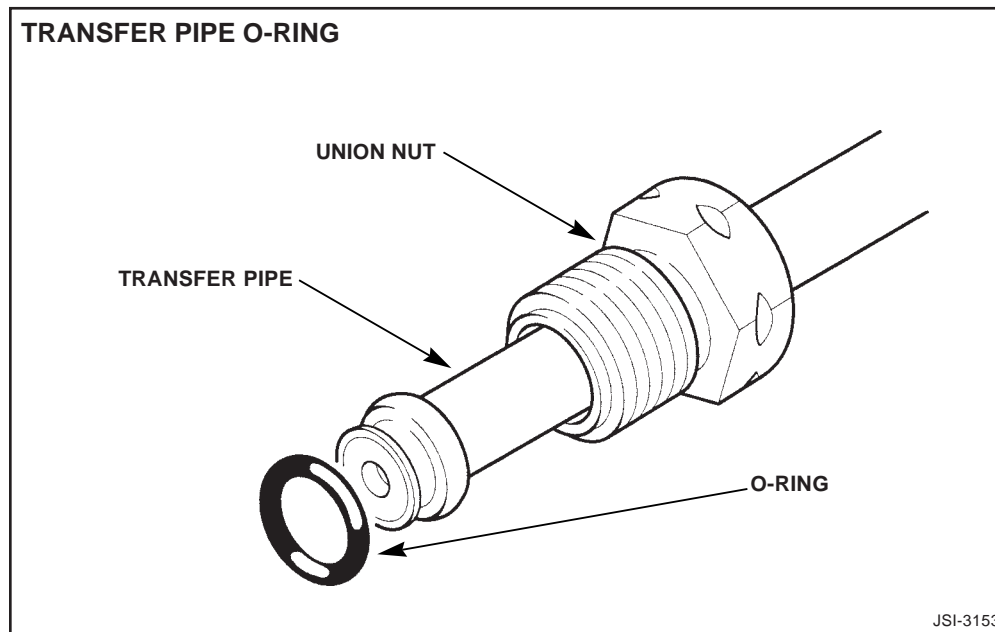
ILLUSTRATION 1

The steering rack of some 1995-97 Sedan Range vehicles may leak at one of the transfer pipe union nuts. The cause of the leak is damage to the O-ring seal beneath the union nut caused during installation. Before replacing the entire steering rack, the O-ring (Illustration 1) should be replaced and the system tested.

11. Thoroughly clean the areas around the threaded ports, lubricate the replacement O-rings and then install them to the transfer pipes.
12. Install the transfer pipes to the rack assembly, taking care not to damage the O-rings against the thread in the port.

13. Thread the union nuts and lightly tighten them while checking that the pipes and the O-rings are properly seated in the bores.
14. Using a crowfoot wrench on a torque wrench, tighten the union nuts to 7 - 8 Nm (5.2 - 5.9 lb ft or 62 - 70.8 lb in).
