Power Windows – Noise During Initial Movement – Install Revised Motor

MODEL 1995 MY
Sedan Range
VIN
720001-754304

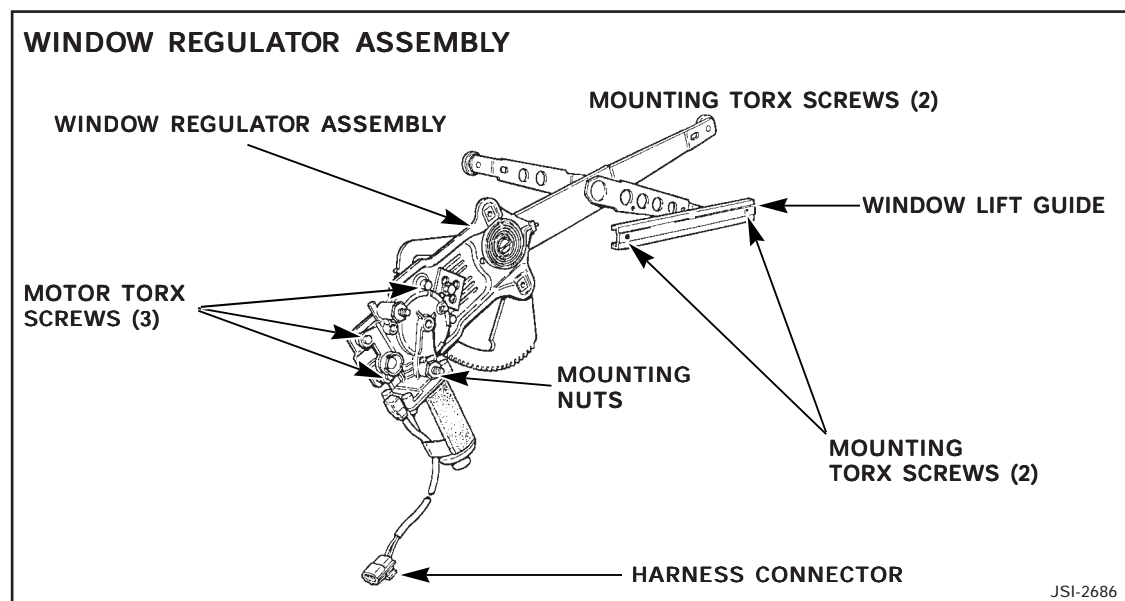
ILLUSTRATION 1

A noise may be heard during initial movement of a window lift mechanism on some Sedan Range vehicles within the above VIN range. To correct this condition, a revised window regulator motor was introduced in production starting with VIN 754305.

1. Remove the veneer panel, and upper and lower trim pads.
2. Using a suitable plastic knife, cut through the sealant bead which holds the water deflector to the inner panel of the door. Move the water deflector aside to allow access to the lift mechanism.
3. Tape the window glass in place using a length of suitable adhesive tape over the upper door frame and fastening it firmly to the glass.
4. Loosen and remove the two torx head screws and the two nuts that retain the window regulator assembly (Illustration 1).

5. After marking their position, remove the two screws that retain the window lift guide (Illustration 1).
6. Remove the harness connector (Illustration 1) from the retaining clip and then disconnect the harness from the motor.

9. Loosen and remove the three torx head screws (Illustration 1) that retain the motor to the regulator assembly and then remove the motor.
10. Place the new motor on the regulator assembly, using care to fully engage the drive pinion and the segment before installing and tightening the retaining screws.
