Sedan Range

TECHNICAL BULLETIN

Rocker Panel Blackout Area – Repaint – Service Action S616

MODEL 1995 MY
Sedan Range
VIN 720001-727823

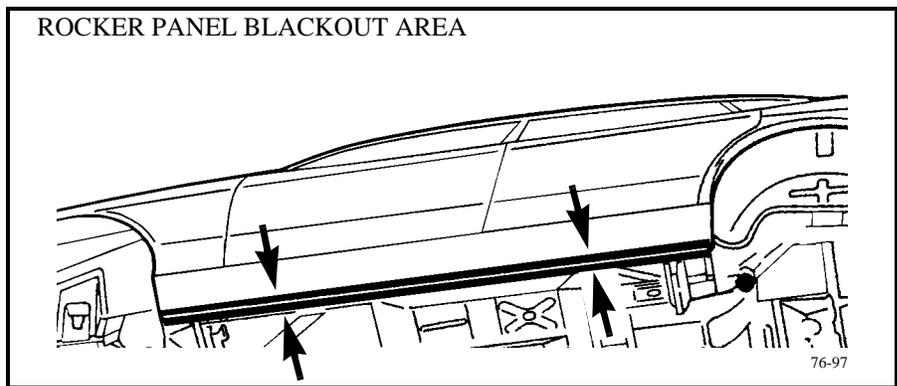
ILLUSTRATION 1

Matte black paint may be missing from the blackout area of the rocker panels (lower sill flanges) following “KATS removal on 1995 MY Sedan Range vehicles from VIN 720001 - 727823.

The high pressure cold water spray used to wash off the “KATS Remover solution may dislodge sections of the matte black paint in rocker panel area.

Following “KATS” removal on Sedan Range vehicles within the VIN range above, inspect the rocker panel blackout areas (Illustration 1). If matte black paint is missing or damaged, perform the following procedure.

1. Thoroughly wash the area with a paint preparation solvent.
2. Mask and repaint with an air drying matte black paint.
