**Door Lock Mechanism – Tight
Operation – Modification Procedure**MODEL 1995-96 MY
Sedan Range

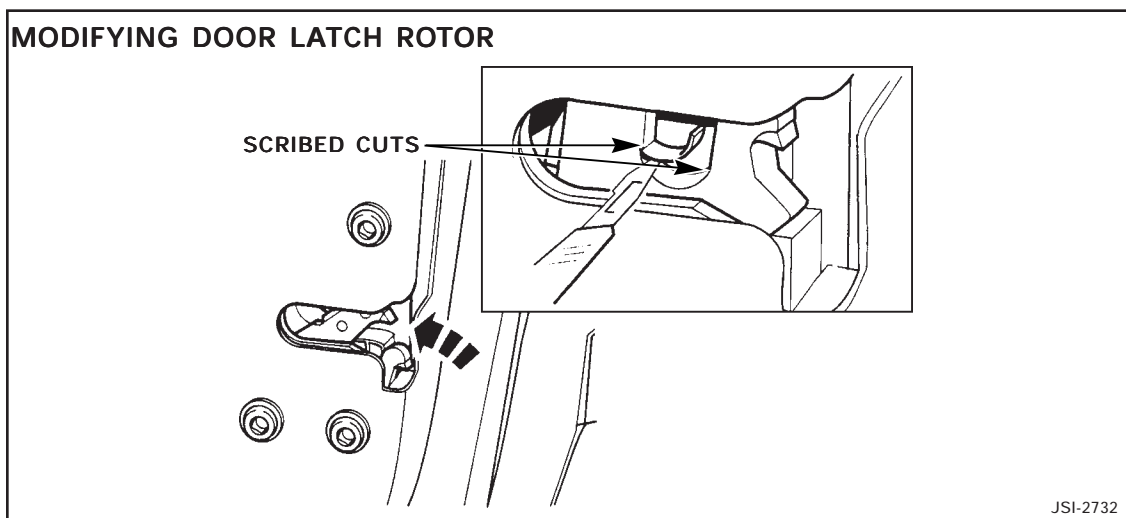
ILLUSTRATION 1

Some 1995 MY-ON Sedan Range vehicles may exhibit tight operation of the door lock mechanism. This condition has been found to be caused by the plastic coating on the latch rotor.

1. Use a screwdriver to move the latch rotor into a partially closed position as shown in Illustration 1.
2. Refer to Illustration 1 and use a sharp knife to scribe two cuts across the width of the latch rotor at each end of the curved portion.

3. Cut away and remove (in one piece, if possible) the curved portion of the plastic coating between the two scribed cuts (Illustration 1). Plastic should only be removed from the curved area of the latch rotor, not on the straight sections. Do not allow the removed pieces to drop into the lock mechanism.

CAUTION: Do not use hand files, rotary grinders or similar tools for this operation, since debris can fall into the lock.
