**Damaged Cupholder –  
Replace Mechanism Only –  
Repair Procedure**MODEL 1995-97 MY  
Sedan Range  
VIN 720001-812255**ISSUE:**

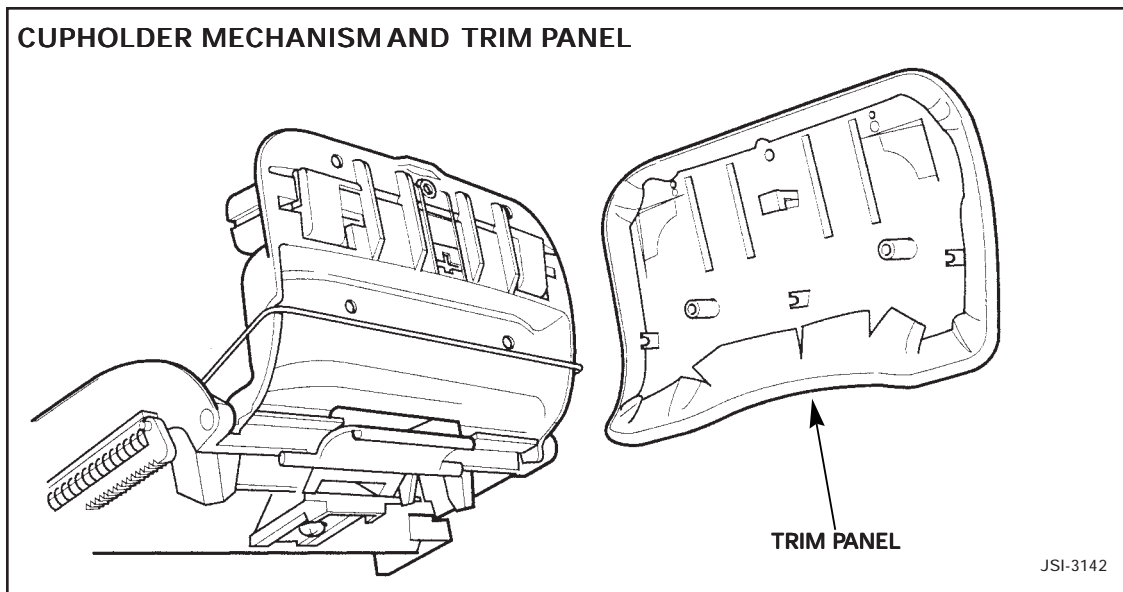
ILLUSTRATION 4

### CUPHOLDER MECHANISM AND TRIM PANEL

7. Discard the damaged mechanism.
