**Damaged Cupholder –
Replace Mechanism Only –
Repair Procedure**MODEL 1995-97 MY
Sedan Range
VIN 720001-812255**ISSUE:**

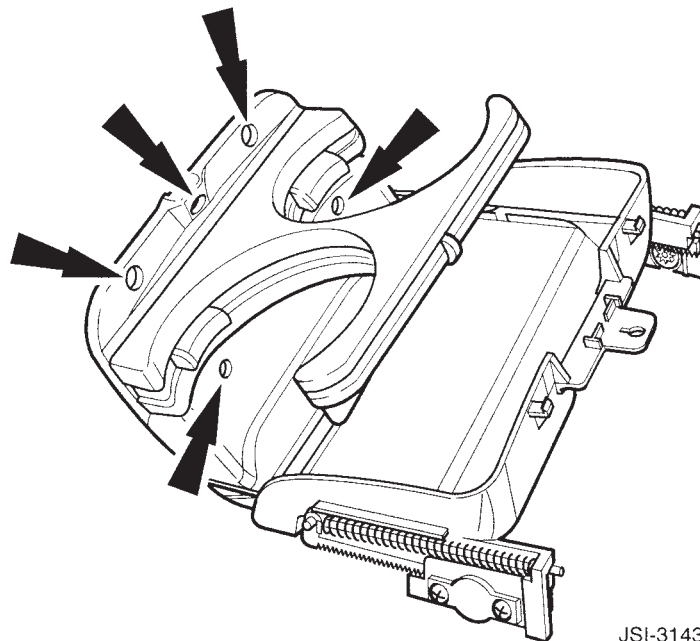
ILLUSTRATION 1

In case of a customer complaint of a broken cup-holder assembly, (shown in Illustration 1), remove the holder and install a new assembly in the cubby box lid as described on the next page.

LOCATIONS FOR TRIM PANEL SCREWS IN CUPHOLDER ASSEMBLY

4. Remove the cup holder latch retaining screw, (Illustration 3).
5. Remove the latch and the cup-holder mechanism with its trim panel from the lid.
6. Remove the five No.T8 Torx head screws, (arrowed in Illustration 1), that retain the trim panel. Remove the panel from the mechanism.

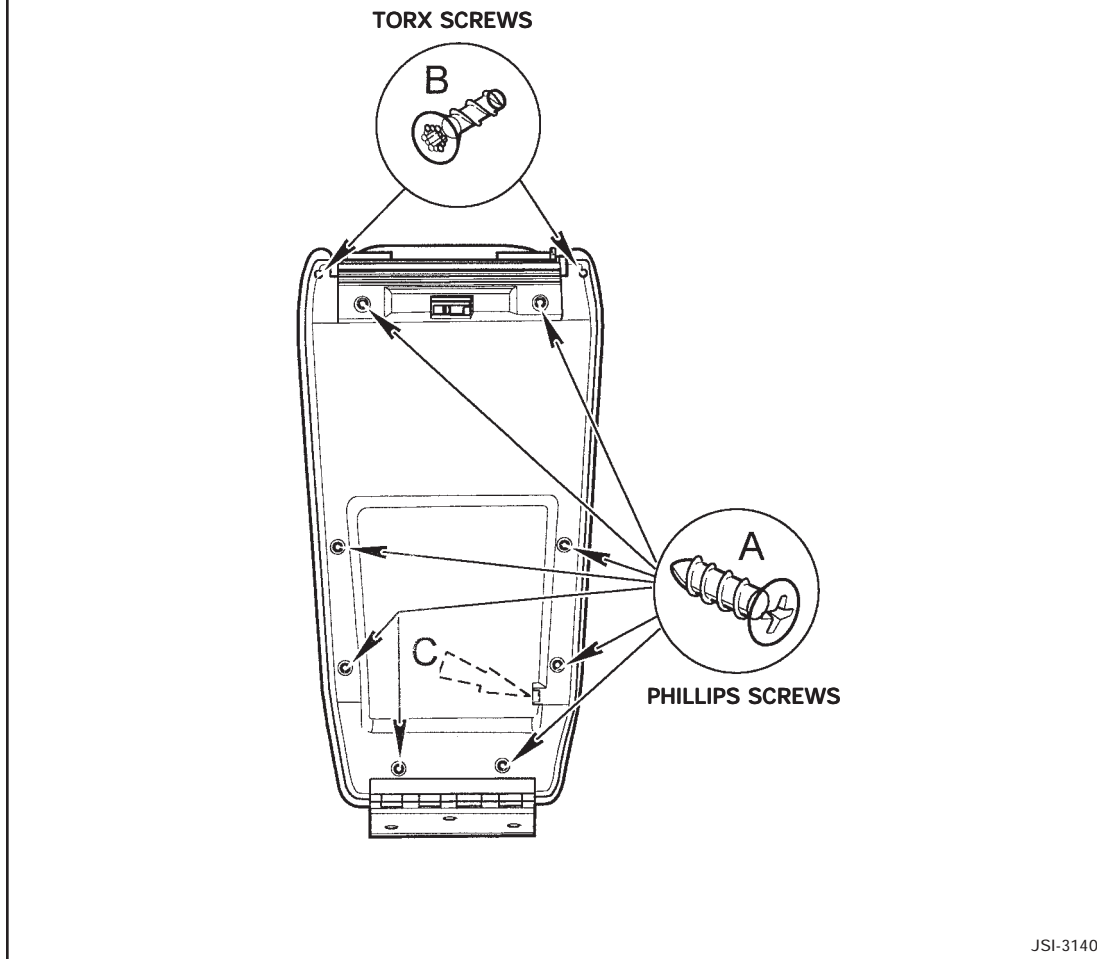
ILLUSTRATION 2

CONSOLE LID RETAINING SCREWS

1. Open the Console Lid and remove the screw, (C, illustration 2), that secures the check arm to the lid.
2. Remove the three screws that retain the lid and hinge to the console. Remove the lid from the console. Place the lid assembly on a clean bench area.
3. Remove the eight phillips-head screws, (A, illustration 2), and the two T8 Torx head screws, (B, illustration 2), that hold the inner finisher to the console lid. Remove the finisher and the hinge from the lid.

- Always refer to the recommended torque settings when assembling the mechanism.
- Ensure that the damper wire, which acts as a check-arm, and the hooked projection, which locates the trim pad to the mechanism, are correctly engaged when the trim panel is installed on the mechanism.
- Check that the slider-plate spring, (Illustration 3), is present and in the correct position and that the latch paddle functions correctly i.e. it must fully latch to the console.
- Ensure that the lock screw, (C, Illustration 2), is present and correctly aligned in the substrate before assembling the lid.

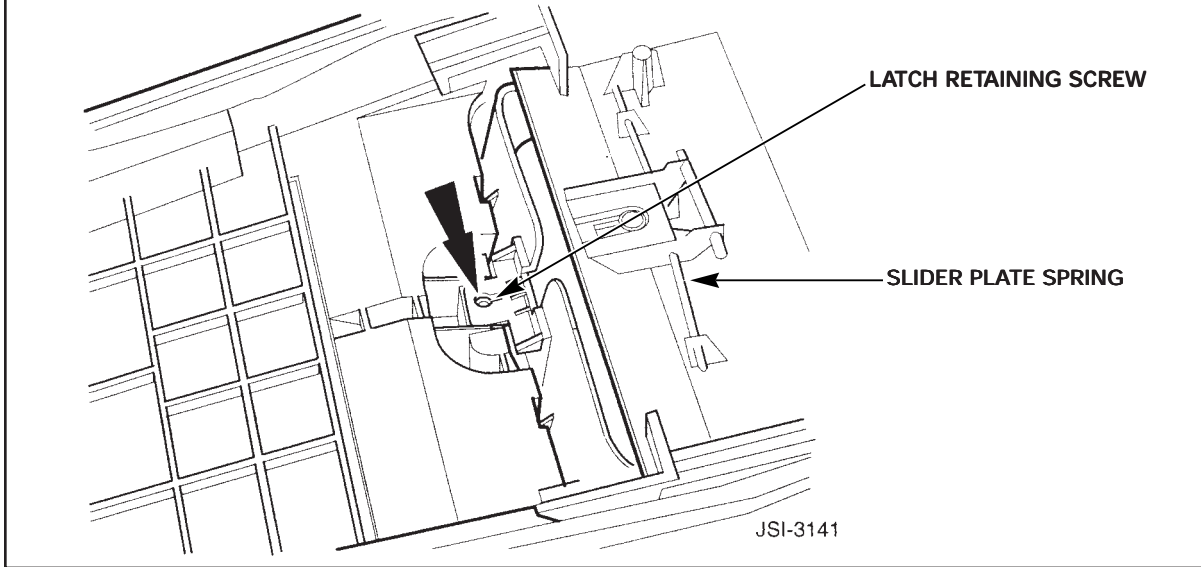
ILLUSTRATION 3

RETAINING SCREWS AND SPRING

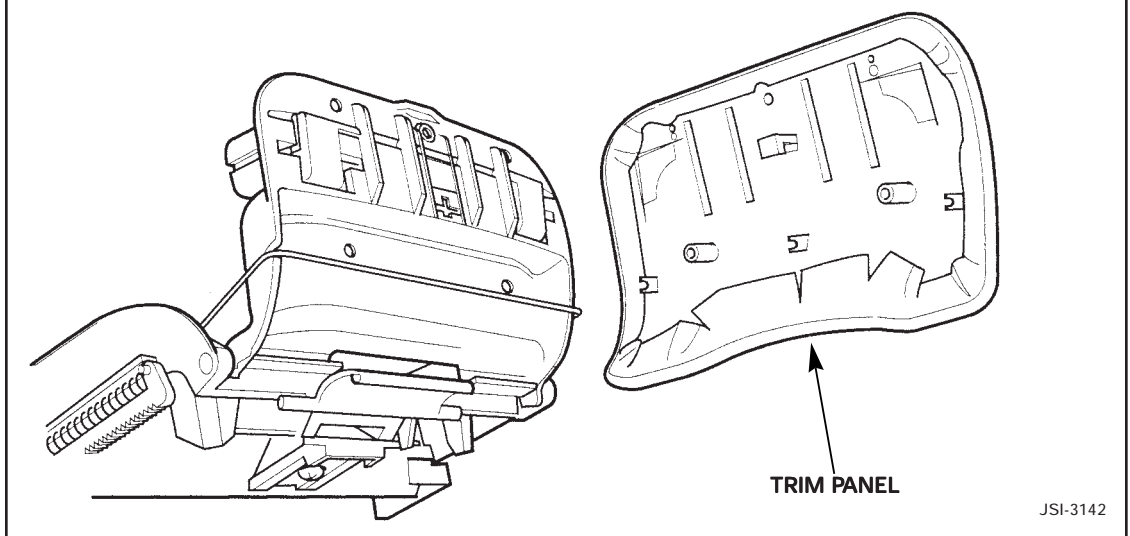
ILLUSTRATION 4

CUPHOLDER MECHANISM AND TRIM PANEL

Note: The trim panel is released by pulling the bottom edge out a little and then pushing upwards, to disengage the hooked projection on the rear of the trim pad from the mechanism.

7. Discard the damaged mechanism.
