Temporary Windshield Fogging After Blower Start-Up – Install Revised Control Module

MODEL 1995 MY  
Sedan Range  
VIN  
720001 - 741196

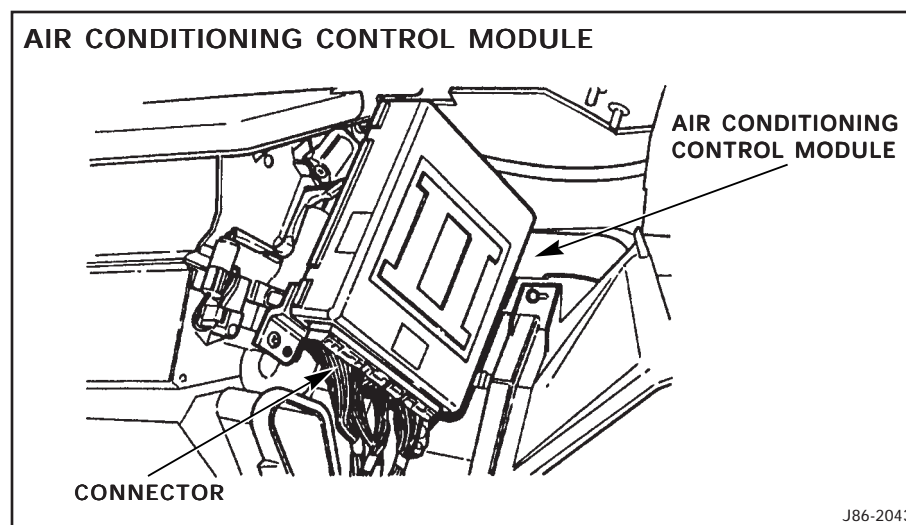
ILLUSTRATION 1

1. Disconnect battery negative cable.
2. Remove the right side dash liner and the right side footwell outlet duct.
3. Disconnect the A/CCM harness connectors (Illustration 1).
4. After removing the screws, remove the A/CCM (Illustration 1).

5. Position the new A/CCM so the mounting brackets engage correctly in the locating pegs and install.
6. Connect the connectors.
7. Align and install the footwell air duct.
8. Install the dash liner.
9. Connect the battery negative cable and reset the clock.
