Sedan Range

14-06

TECHNICAL BULLETIN

Cooling System Fan Fuse Failure – Single Pressure Switch – Service Modification

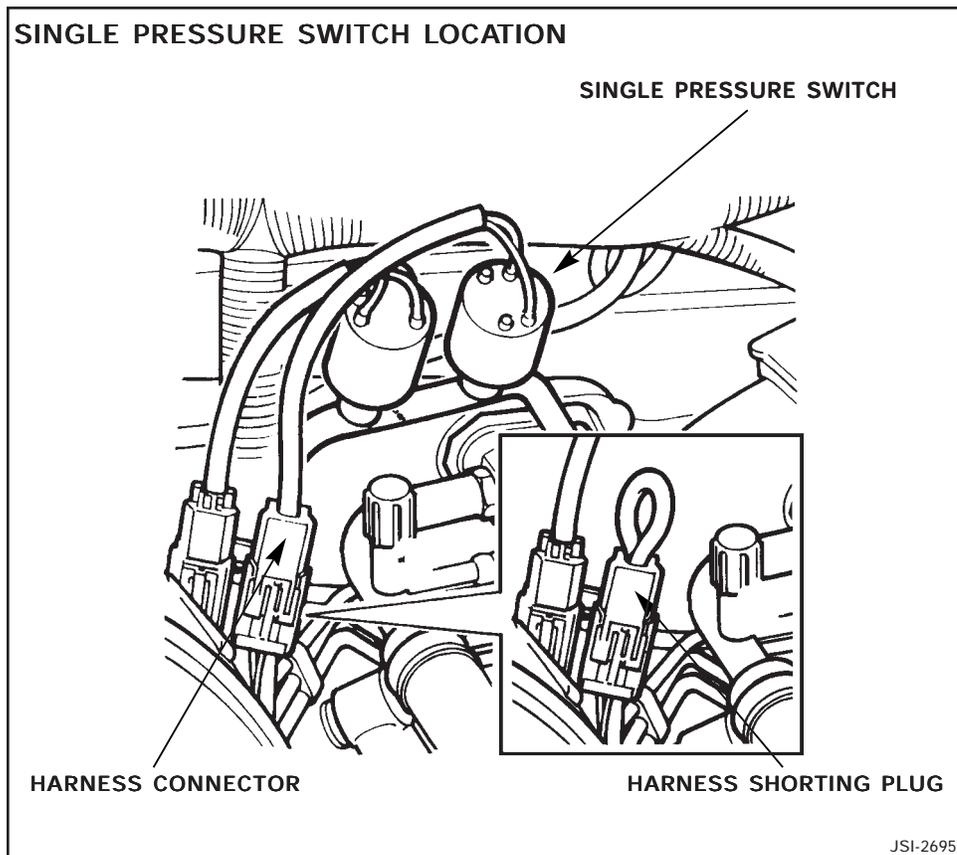
ILLUSTRATION 1

Technical Bulletin 14-04, Dated 10/95 described cases of repeated cooling fan fuse failure caused by failure of the single pressure switch, which controls slow fan speed operation.

Following investigations into this concern and reappraisal of vehicle operating conditions, the single pressure switch has been deleted from the vehicle specification starting with VIN 761570. The switch has been replaced by a shorting plug. The cooling fans will now operate continuously at slow speed when the ignition switch is in position II (normal engine running position). This means the 86°C contacts on the radiator thermostatic switch are now redundant. High speed mode is still controlled by the refrigerant triple pressure switch and the radiator thermostatic switch as before. Refer to Fig. 7.1 of the Sedan Range 1995 Electrical Guide.

If the cooling fan relay module has failed in either a short circuit or open circuit mode, the cooling fan circuit **must** be modified as described on the next page in addition to replacing the relay module. The modification is necessary because of the known failure mode of the pressure switch, which may cause sticking of the relay contacts and/or may switch the fans into a parallel circuit condition (high speed mode), causing the fan fuses to blow.

1. Identify the single pressure switch (Illustration 1) and disconnect the harness connector.
2. Unscrew and remove the single pressure switch from the Schrader valve connection (Illustration 1) on the refrigeration line.

3. Install and tighten the dust cap provided in the modification kit on the exposed Schrader valve connection.
4. Remove the harness connector from its mounting bracket.
5. Insert the shorting plug supplied in the modification kit into the harness connector. Insert the harness connector into its bracket.
6. Turn the ignition switch to position II and check that the cooling fans run at the slow speed.
