Sedan Range

TECHNICAL BULLETIN

Positive Start Cable –
Reroute –
Service Action S629

MODEL 1995 MY
XJR Sedan
VIN 720125-745782

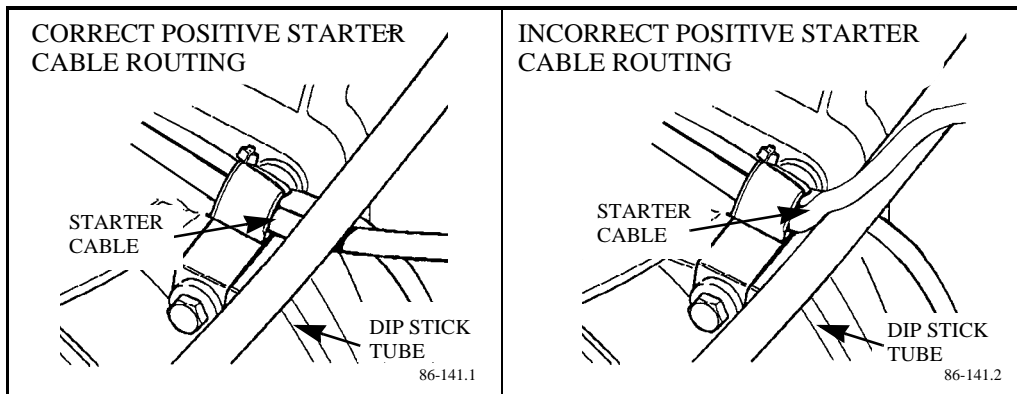
ILLUSTRATION 1

The positive starter cable may be incorrectly routed in 1995 MY XJR Sedan vehicles from VIN 720125 - 745782.

The CORRECT routing of the positive starter cable is shown in Illustration 1. (Starter cable routed BELOW the automatic transmission dipstick tube.

The INCORRECT routing of the starter cable is shown in Illustration 2. (Starter cable routed ABOVE the automatic transmission dipstick tube)

1. Disconnect the battery negative cable.
2. Remove the positive starter cable from the right side firewall stud.
3. Reroute the starter cable from above the automatic transmission dip stick tube (Illustration 2) to below the automatic transmission dipstick tube (Illustration 1).

4. Reconnect the starter cable to the firewall stud and reposition the rubber boot.
5. Reconnect the battery and the clock.
