Interior and Fascia Panel Lighting Malfunctions – Harness Chafing Behind Radio

MODEL 1995 MY
Sedan Range
VIN 720001-ON

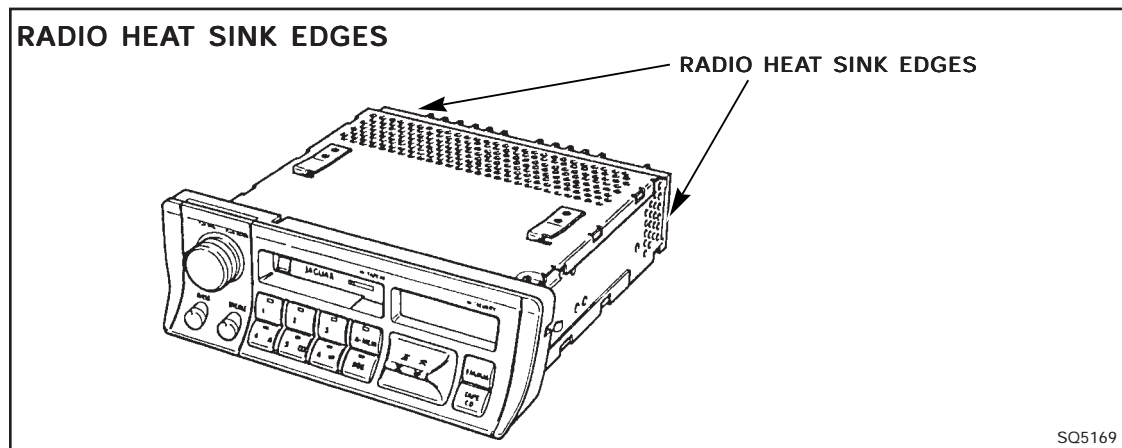
ILLUSTRATION 1

1995 Sedan Range vehicles may experience fascia panel lighting and interior lighting malfunctions that can be caused by the back of the radio (Illustration 1) chafing on the fascia harness, In-Car Entertainment (ICE) system harness or the center console harness (Illustration 2).

3. If chafing is found, repair the wires, apply suitable protection such as 3M Glass Cloth Tape (part no. 27 or 69) or convoluted tubing to the harness and secure the harness away from the sharp edges of the radio chassis and heat sink.
4. Check the operation of the systems listed on page 1.
5. Reinstall the climate control panel and the radio.
6. Check the operation of all systems.
