Damaged Wiring Harness – Possible Intermittent Engine Misfire/No Start – Remove Harness Clip

MODEL 1995-96 MY
Sedan Range
VIN
720001-770946

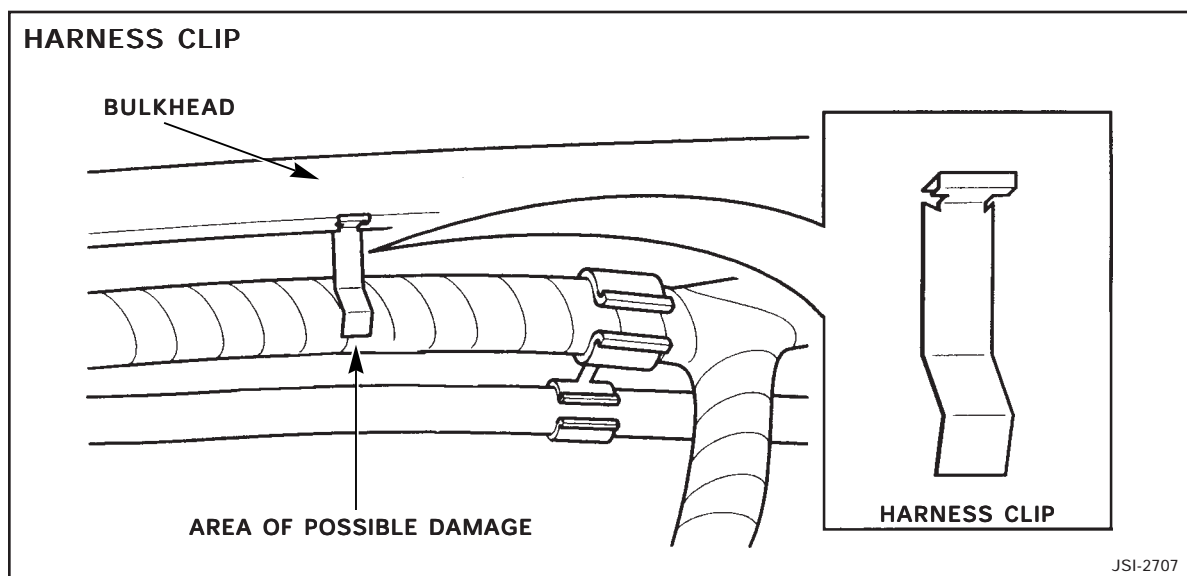
ILLUSTRATION 1

Some Sedan Range vehicles within the above VIN range may exhibit a condition of engine misfire/no start, which can be caused by a clip shorting the engine management harness to ground. The clip, which is located on the bulkhead on the right side of the engine compartment (Illustration 1), may cut into the harness causing a short circuit.

The clip is not found in this location on all vehicles and was deleted from the vehicle build specification after VIN 770946.

Remove and discard the clip on all vehicles where it is found, to eliminate the possibility of it penetrating the harness.

In case of a customer complaint of engine misfire/no start, check if the clip is present and if it has penetrated the harness. Remove and discard the clip. Test to verify if the harness has been damaged and repair as needed.
