**SRS Airbag MIL Illumination – DTC 32 –
Secure Connector**

MODEL 1995-96 MY
Sedan Range

VIN
720001-777462

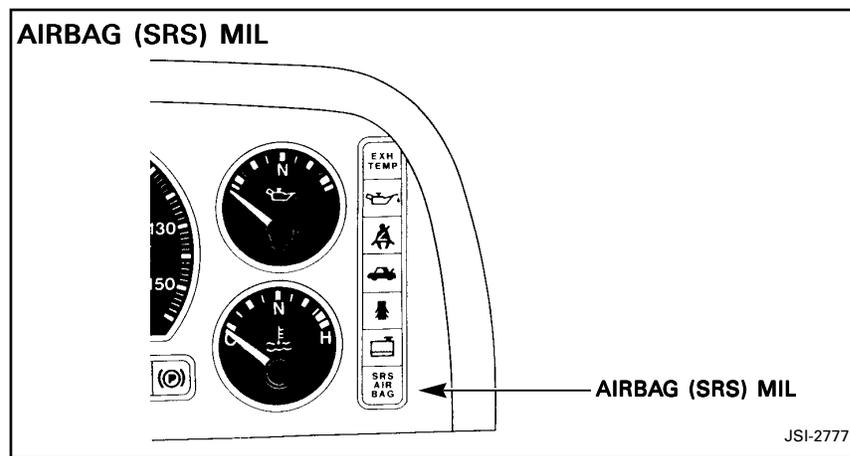
ILLUSTRATION 1

Some 1995-96 MY Sedan Range vehicles within the above VIN range may exhibit an Airbag fault where the Supplementary Restraint System (SRS) Airbag Malfunction Indicator Lamp (MIL) remains lit (Illustration 1) after the 6 second self-test function.

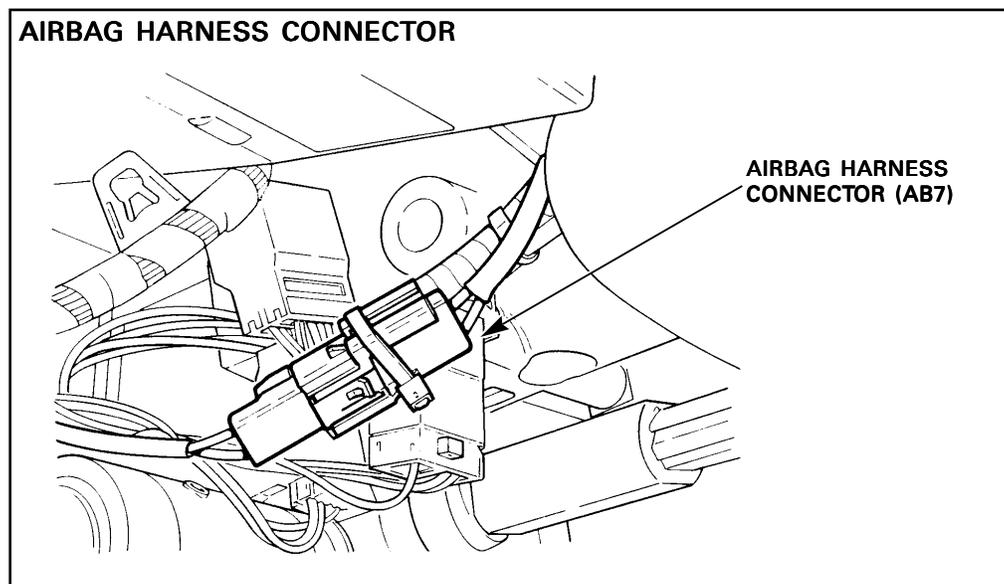
ILLUSTRATION 2

6. Remove the driver side dash liner and identify the harness connector for the driver's airbag (Illustration 2). The connector is black with a red/purple wire and a pink/brown wire, both covered by one yellow sleeve, between the airbag and the connector.
7. Disconnect the connector and inspect the terminals and the shorting bar.

10. Use the PDU to check that DTC 32 was not stored again. If not, proceed to step 11. If DTC 32 is still present, the connector is defective. Disconnect the battery negative cable and replace the cable reel cassette, refer to the XJ6-XJ12 Vehicle Service Manual, section 15.1.20, Cable Reel Cassette, Renew.
11. Position the connector against the adjacent harness (Illustration 2), and secure the connector to the harness using a tie strap to firmly hold the connector in position.
12. Reconnect the battery negative cable and wait 1 minute before proceeding to the next step.
13. Turn the ignition on and allow the Airbag/SRS to complete the self-test.
14. Use the PDU to verify that DTC 32 was not stored again.
15. Reset the clock.
