Intermittent No Crank -  
Starter Cable Loose at Bulkhead Terminal -  
Check Terminal Torque

MODEL 1995-96 MY  
Sedan Range  
VIN  
720001-778598

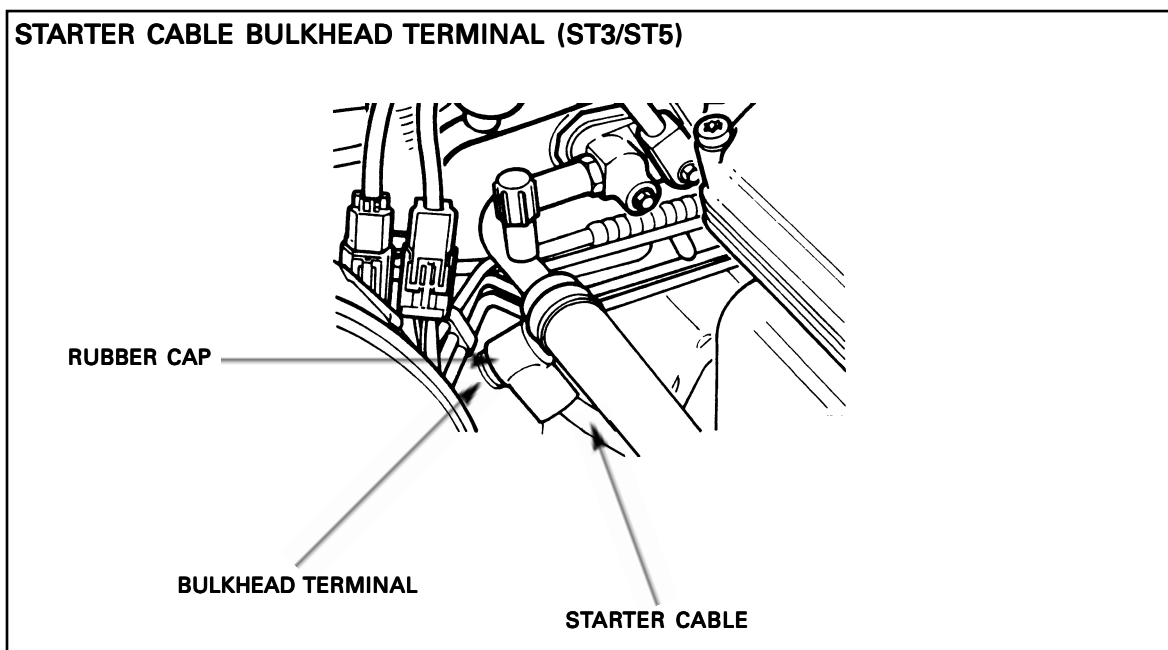
ILLUSTRATION 1

Some 1995-96 MY Sedan Range vehicles within the above VIN range may experience an intermittent no crank condition. The condition can be caused by a starter link cable that is loose at the bulkhead terminal (ST3/ST5).

When investigating a customer complaint of an intermittent no crank condition, check the bulkhead terminal (ST3/ST5) for looseness (Illustration 1).

1. Disconnect the battery negative cable.
2. Pull up the rubber cap and torque the nut to 62 - 88.5 lbs. in. (7 - 10 Nm.) to ensure a tight connection.
3. Reconnect the battery and reset the clock.
