**Squeaks & Rattles – Airbag Door –
Adjusting Clearances**

MODEL 1995 MY
Sedan Range
VIN
720001-743138

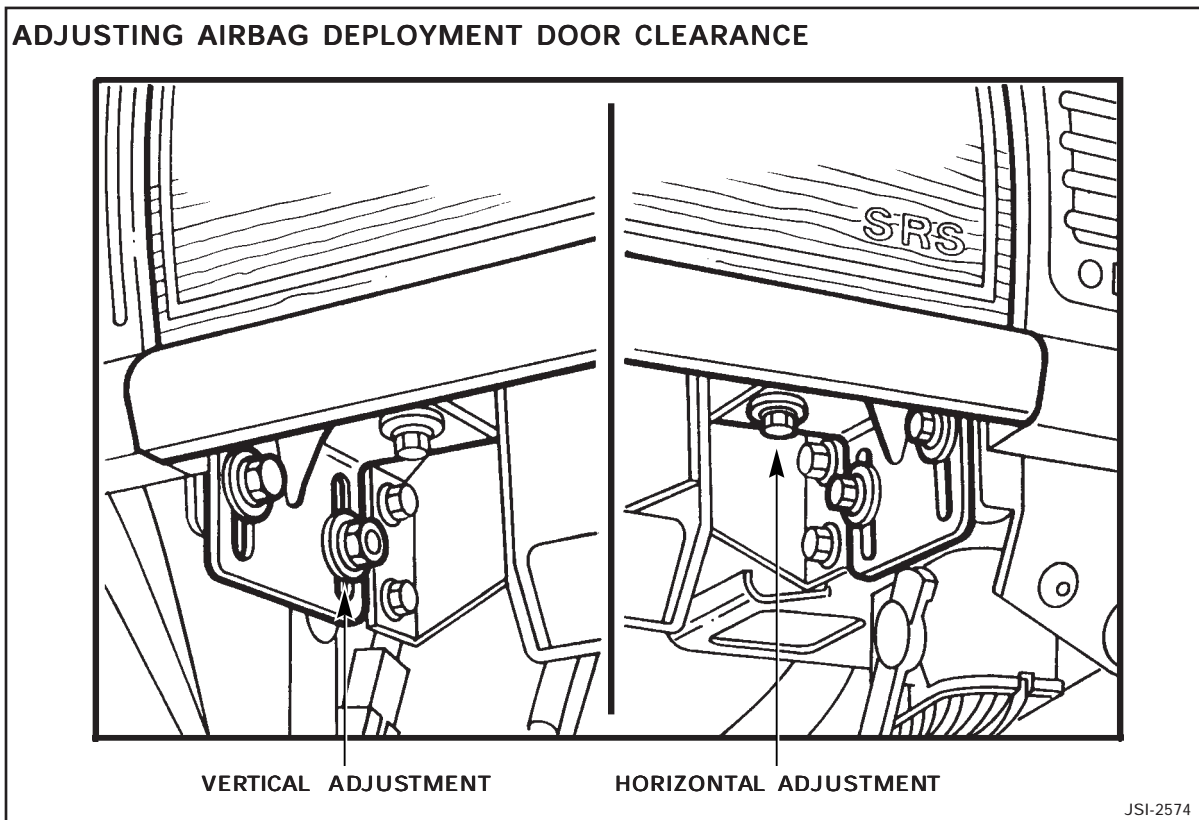
ILLUSTRATION 1

Some 1995 MY Sedan Range vehicles within the above VIN range may experience squeaking from the airbag door rubbing against the adjacent fascia panel veneer. This condition can be repaired by realigning the deployment door.

- Remove the underdash liner (up to VIN 739426) or the glove box (VIN 739427-ON),
- Vertical adjustment of the door assembly is made by loosening the four horizontal bolts (Illustration 1).

- Horizontal adjustment of the door assembly is made by loosening the four vertical bolts (Illustration 1). These bolts allow adjustment both left and right and in and out.
- Torque the bolts to 39 - 44 lb. inches (4.5 - 5 Nm)
- When installing the airbag door, note the following:
 - the door should be centered in the opening
 - the bottom trim roll of the door must align with the bottom trim roll of the fascia.
 - the door veneer must be level with the adjacent fascia panel veneer at all points.
